CHAPTER 4A

QUICK-BUILD PILOTS

4A.1.0 Introduction

4A.1.1 Broadway

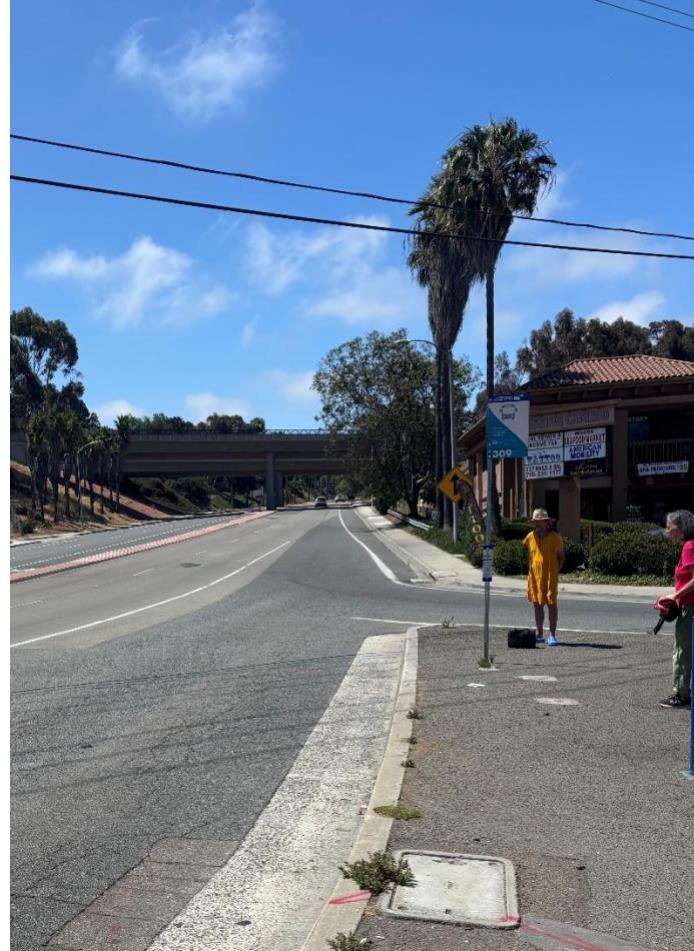
4A.3 Mission Avenue and Mesa Drive (Amick St.)

- **Existing conditions:** Currently, buses queue with general traffic at the light, often facing delays during peak periods before reaching the far-side bus stop. There is an existing median separating forward traffic lanes and a right-turning lane.
- **Proposed configuration:** Convert median into dedicated bus queue jump lane by taking away some excessive width from the existing four lanes to create a 12-foot bus lane, as requested by NCTD. A sharrow is included to allow cyclist to use this zone as well.
- **Benefit:** This allows buses to bypass general traffic and proceed directly to the stop.

- **Existing conditions:** At present, buses pull to the curb to serve a near-side stop, then they must merge back into traffic, causing delays.
- **Proposed configuration:** Move the bus-stop to the far side of the intersection, with an existing bicycle lane being converted into a turning pocket buses can also use as a queue jump lane. A sharrow is included to allow cyclist to use this zone as well.
- **Benefit:** This enables buses to skip the traffic queue while still serving riders.
- **Signal enhancement:** At both queue jumps, a small bus signal may be installed to give buses a leading signal over general traffic. Initially, this would be a simple timed signal but could later be upgraded once a corridor-wide TSP system is in place.

- **Existing conditions:** Existing crosswalks, currently marked only by white border striping
- **Proposed configuration:** Crosswalks at the intersection are enhanced with bold horizontal striping for higher visibility to improve pedestrian safety and bus stop access

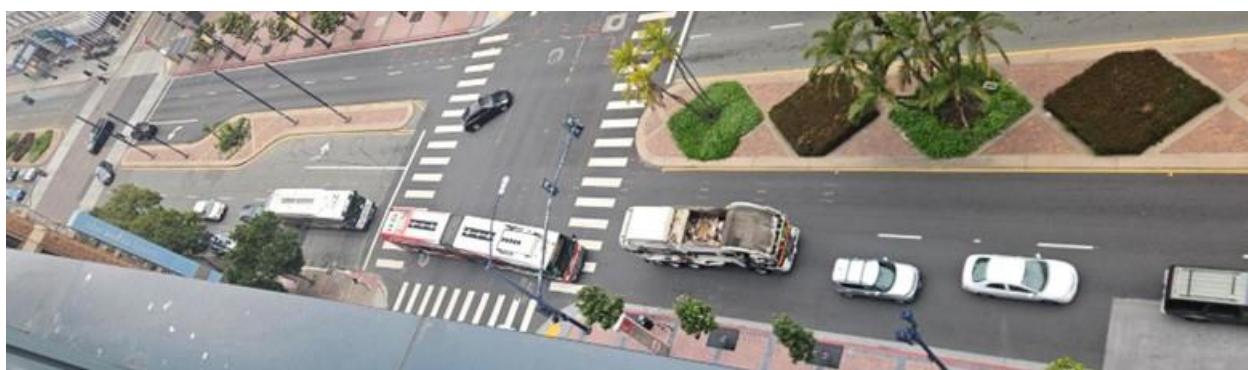
Our observations of auto behavior were at the intersection level, and observed between 71 and 233 cars per hour in the right lanes of different intersections (Table 4A.1.1). This shows that there is a significant number of cars contending with buses for curb space, intersection queues, and generally impeding bus operations.

The observations indicate that the majority of cars (57%) we observed in the right lane along the entire corridor were through-traffic at any given intersection. Therefore, bus priority treatments could possibly remove more than half of the cars currently sharing the right lane with buses, if the only cars to continue using the right lanes are those which are turning right. Additionally, on blocks without right-turning intersections (such as those with a one-way cross-street), it can be assumed that all cars will be removed from the right lane. This could improve bus operations.

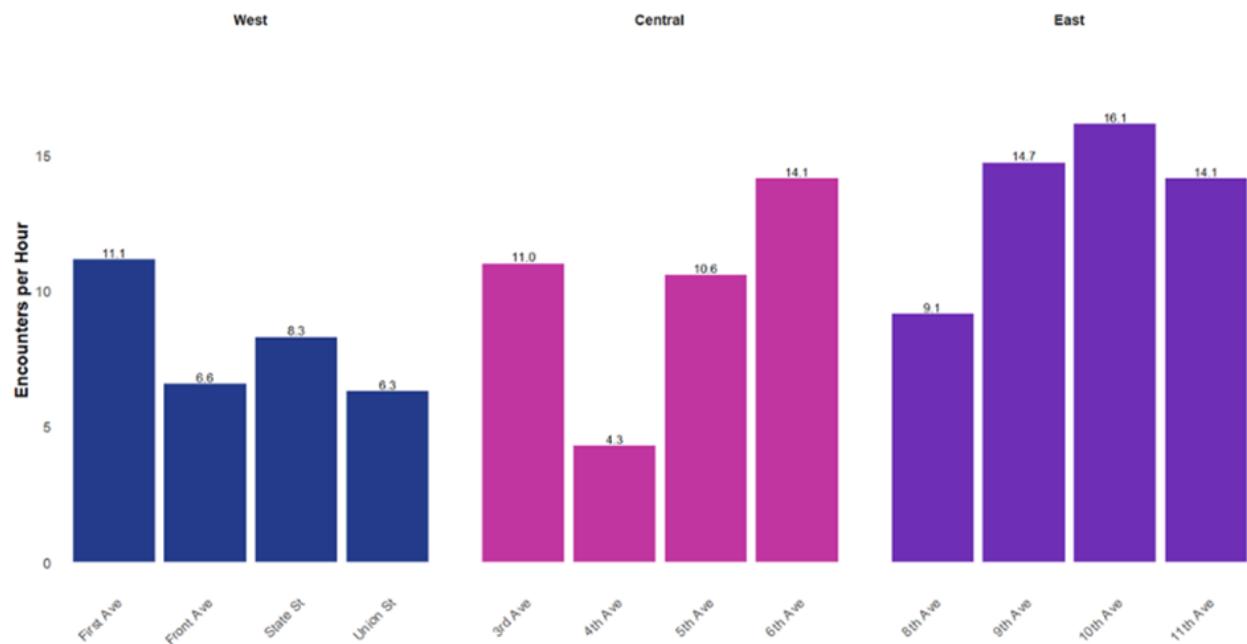
Figure 4A.1.1: Red Light Encounters per Hour by Intersection

The purpose of this analysis was to identify if there are intersections which consistently cause issues for buses along Broadway, and which could be flagged for signal improvements.

Intersection delay: Intersections were analyzed to determine how frequently buses encounter red lights: Red lights are a frequent source of bus delay on Broadway. Within a stretch of 4 intersections (our unit of study), most buses stop at 1–2 red lights per segment. Delays vary significantly by segment:

- The eastern part of the corridor is the most congested, with the highest average red-light delays and busy intersections like 11th Avenue recording the most stops.
- The central segment (especially 5th and 6th Avenues) also experiences high delays.

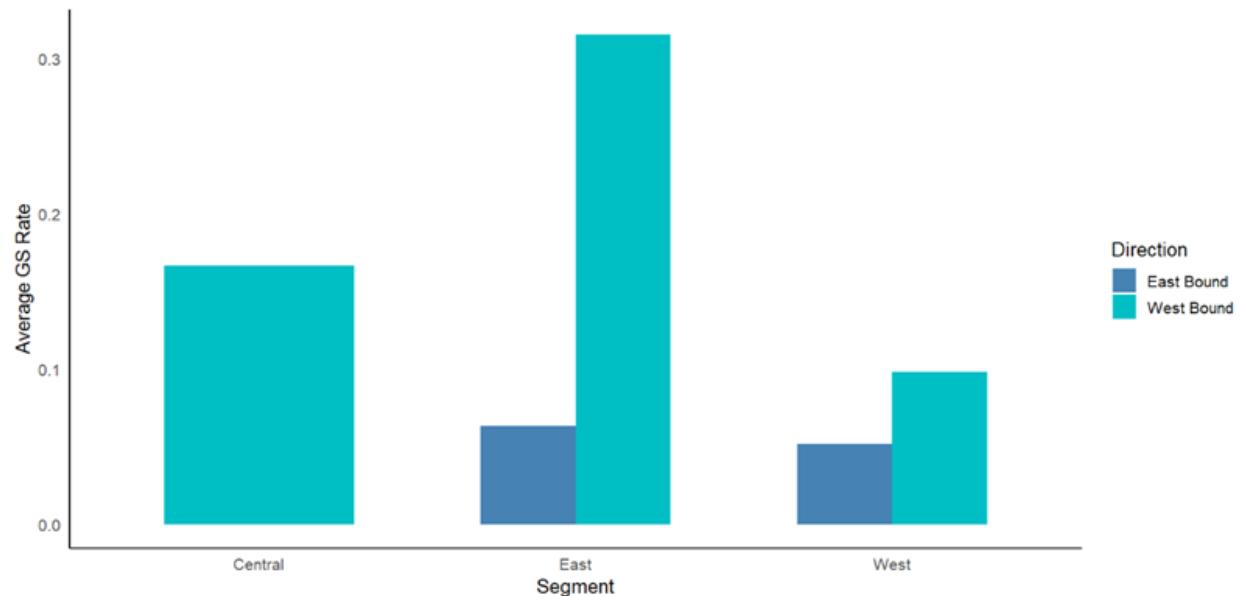
Figure 4A.1.2: Stops on Green Lights by Segment and Direction

Figure 4A.1.2 highlights the percent of buses on a given segment that stopped at a green light at least once.

The primary cause of stopped traffic at green lights for buses was near-side bus stops, which made buses stop regardless of the light condition. However, for general traffic, pedestrian crossings often led to cars standing at green lights while waiting to turn right. This would not be affected by changes to signals.

Stopping at green lights: Buses were found to often stop at green lights, typically because they must load or unload passengers. They often then had to wait for a full red signal cycle afterwards. Signal timing improvements could perhaps benefit this issue.

- Buses stop at green lights 16% of the time, often due to traffic queues from right turning vehicles waiting for pedestrians or long boardings.

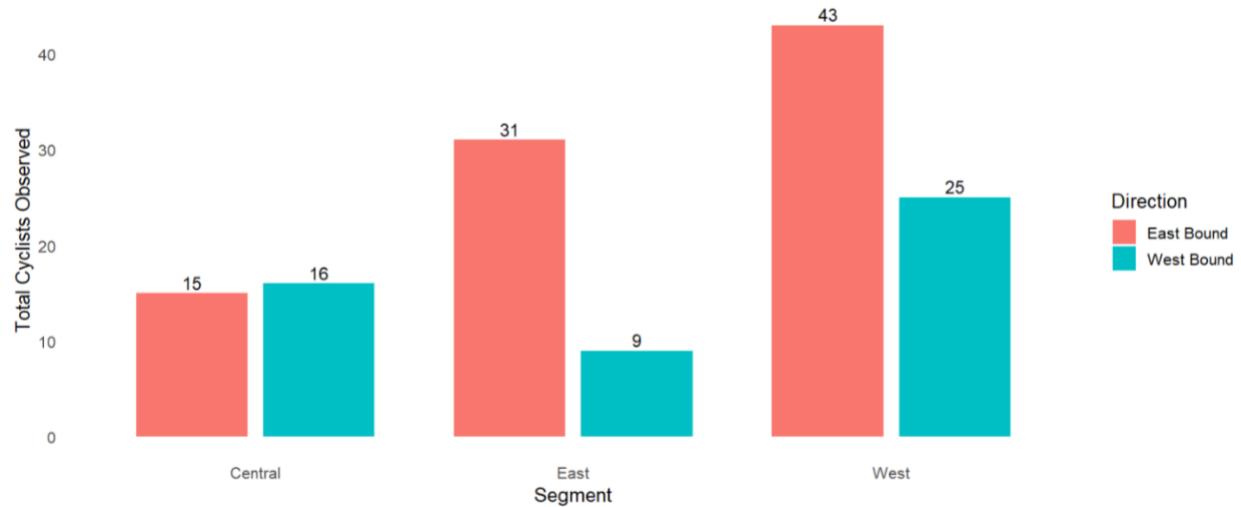
Figure 4A.1.3: Cyclists Presence on Broadway by Segment and Direction

This graph shows:

- The West segment sees the most cycling activity overall, with 43 eastbound and 25 westbound cyclists observed.
- The East segment had many riders in the eastbound direction, but relatively few westbound riders.
- The Central segment has the lowest cyclist volume, with nearly equal traffic in both directions.
- This data aligns with the expectations of the project team, as the cycling experience in the West segment is more safe than in the other segments, leading cyclists to be more prevalent in that area. The Central segment is relatively cramped and unsafe for bicyclists under present conditions, which may lead riders to avoid that stretch of Broadway.

Bicycles: Cyclist presence was measured to assess existing demand for bicycle infrastructure:

- High cyclist volumes occur in the westernmost portion of Broadway, especially in the eastbound direction.

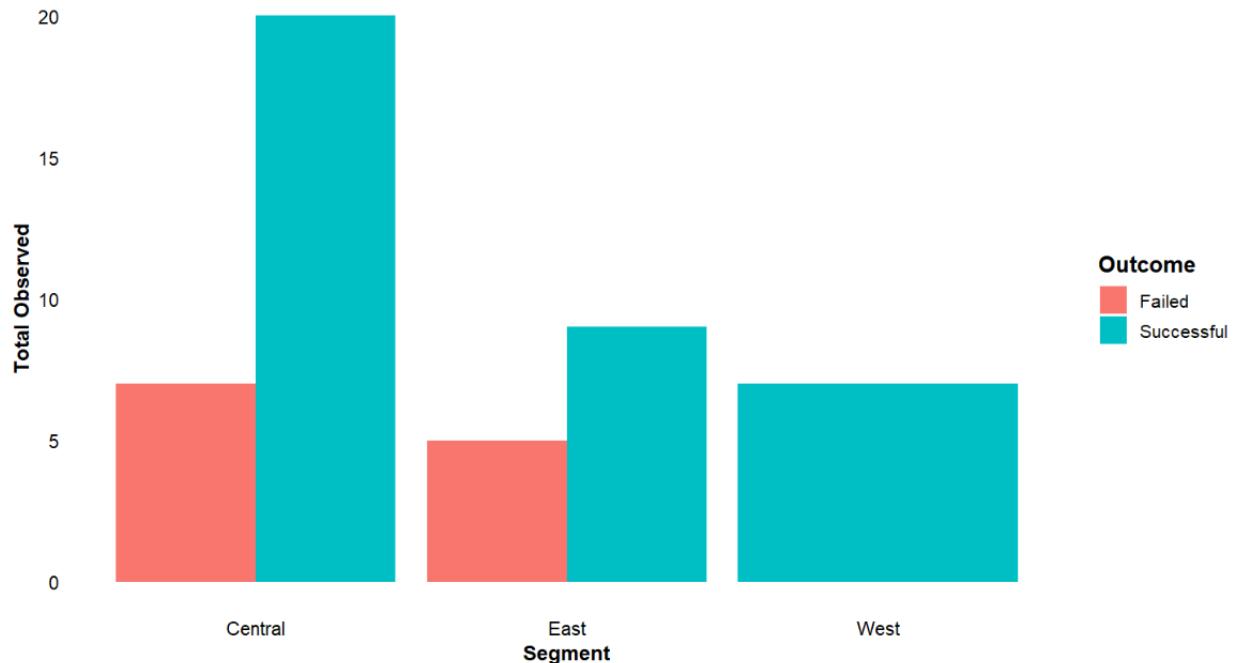
Figure 4A.1.4: Bus Passing Activity by Segment and Block

Figure 4A.1.4 shows where bus passing happened most frequently. The Central segment had the most bus passing action, which coincides with the Central segment having the most bus activity in general.

Buses passing: How often buses had to pass each other at bus stops was measured to assess operational impacts:

- Bus passing presents a significant operational challenge for bus priority lanes.
- The central segment experiences bus volumes high enough to generate significant bus passing movements, requiring buses to leave the curbside lane frequently.
- If vehicle volumes in the “inside” lane (the one away from the curb) increase as a result of the bus priority lane, buses may have more difficulty merging into general traffic, potentially exacerbating bus passing challenges.

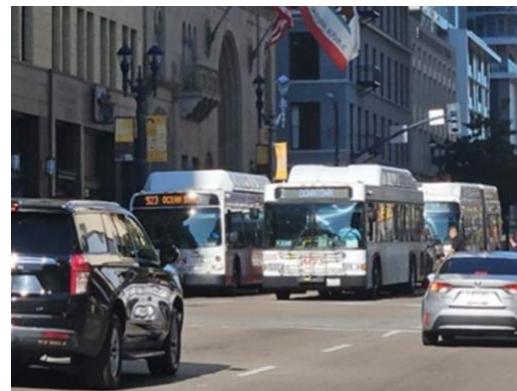
With Rapid and local buses interacting frequently, and Rapid and local bus stops alternating on different blocks, buses were sometimes observed “leapfrogging” and passing each other at stops.

Note: Buses passing each other

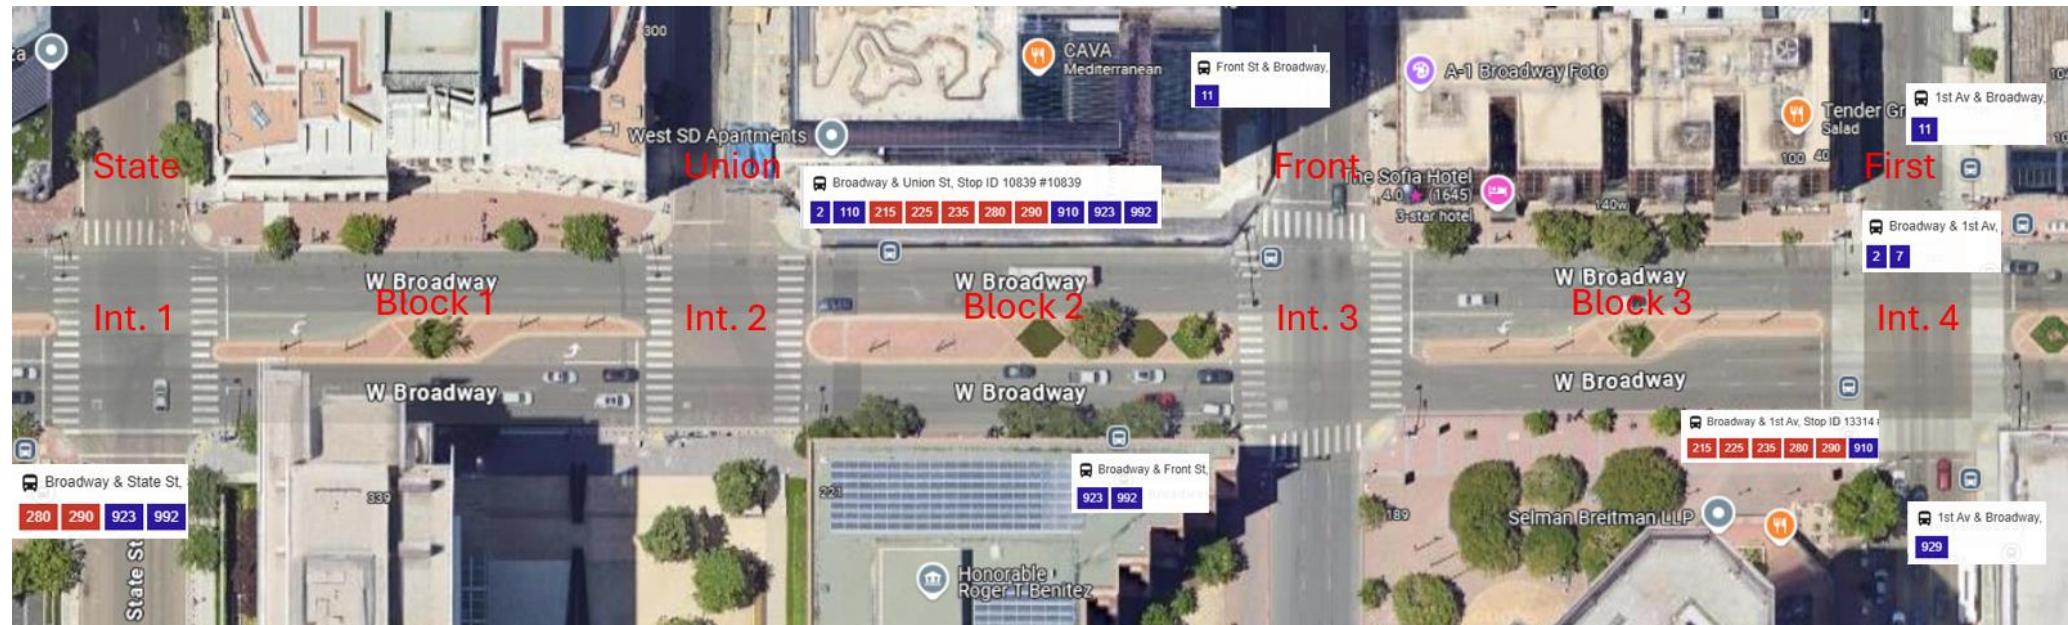
West Segment:

Times
Early: 7:30 to 8:30
Morning Peak: 8:30 to 9:30
Mid Day: 11:30 to 12:30
Afternoon: 4:30 to 5:30

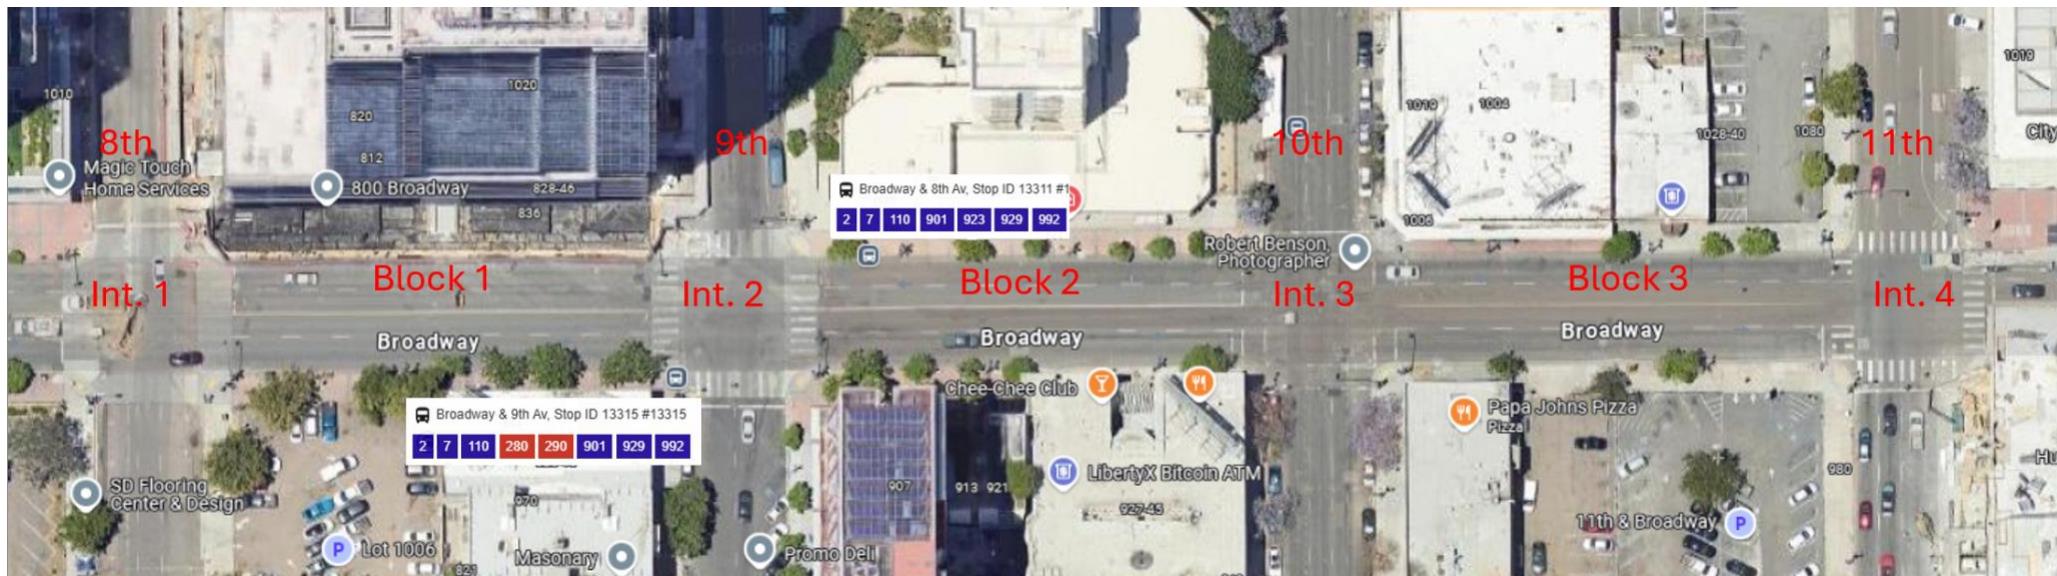
East Segment:

Times
Early: 7:30 to 8:30
Morning Peak: 8:30 to 9:30
Mid Day: 11:30 to 12:30
Afternoon: 4:30 to 5:30

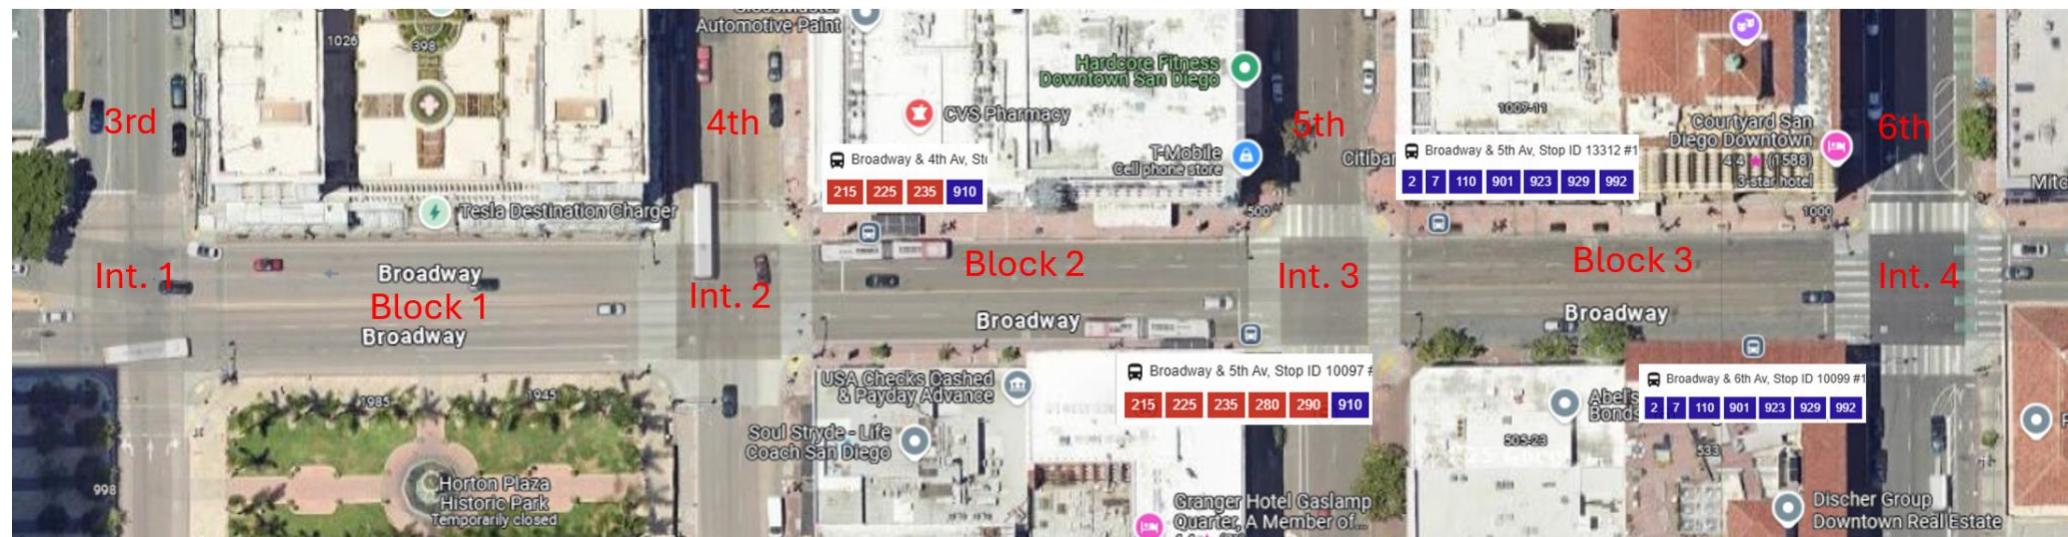
Central Segment:

Times
Early: 7:30 to 8:30
Morning Peak: 8:30 to 9:30
Mid Day: 11:30 to 12:30
Afternoon: 4:30 to 5:30

PERSON 1: Behavior of automobiles in the right lane

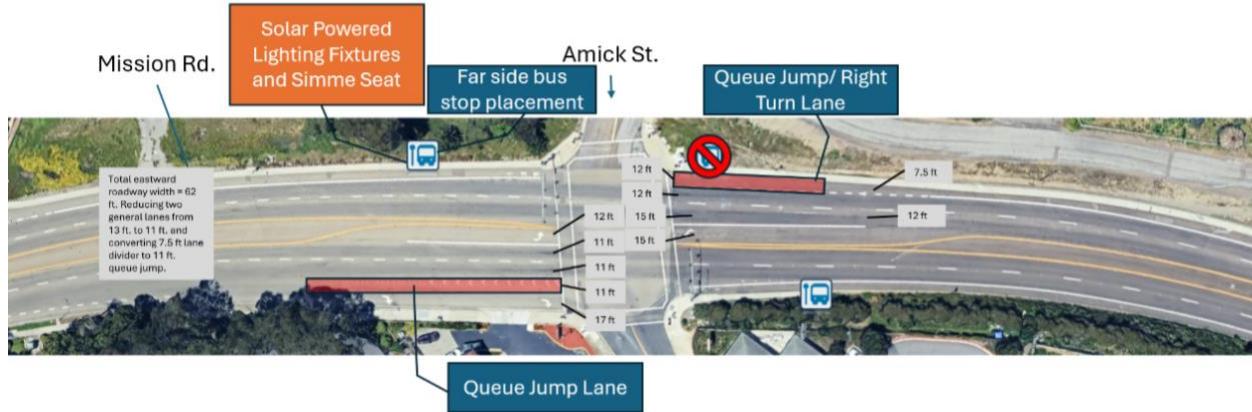
At the time of the site visit, the PDT had initially proposed the recommendations highlighted in Figure 4A.2.1: Initial Recommendations for Mission Ave & Amick St./Mesa Dr. for this segment of the corridor:

- Check grade of sidewalk where we are proposing a far side stop and potential alternative seating
- Observe merging of bus with general traffic at bus-stops
- Observe prevalence of right turning traffic on both sides

Many of the proposed improvements appear feasible given current corridor conditions.

- ADA ramp deployment appears to not be affected by proposed recommendations.
- Queue jump lanes are viable but may benefit from lengthening to increase their effectiveness

- Far-side stop placement is supported, though sidewalk grades and alternative seating should be considered where needed.
- There is adequate room for marked bike lanes and buffers (noted at approximately 3 feet), and right-turn signage may be necessary to guide drivers more clearly.

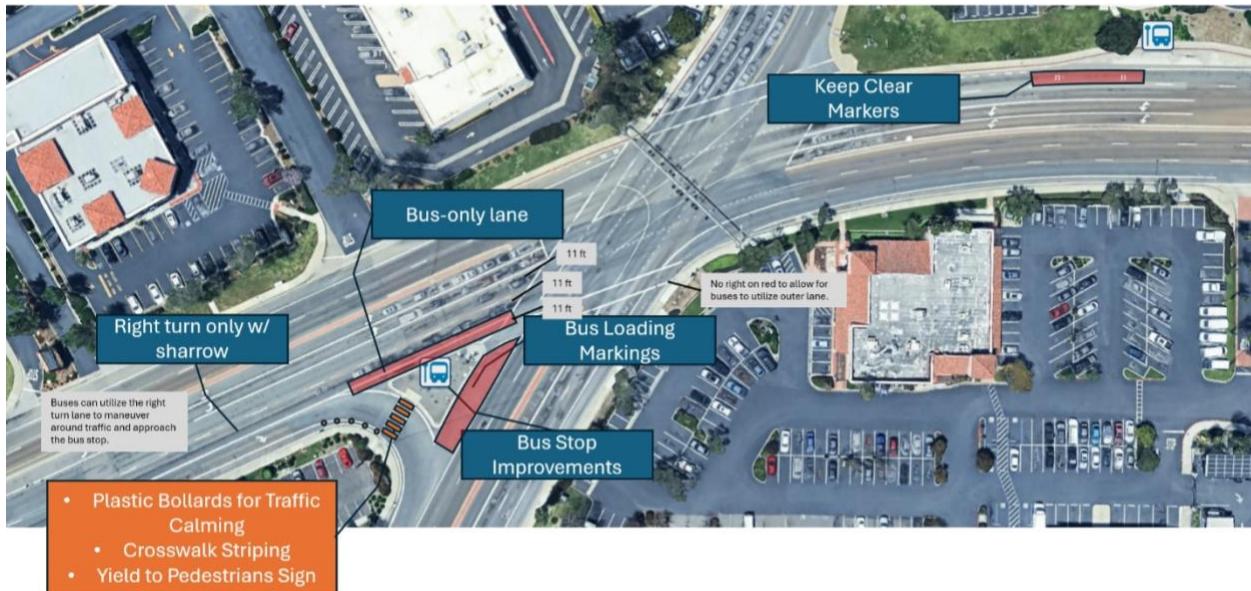
Figure 4A.2.2: Initial Recommendations for Mission Ave & El Camino Real

At the time of the site visit, the PDT had initially proposed the following recommendations for this segment of the corridor:

- Observe merging of bus with general traffic at bus-stops
- See if there is space for a bus-only lane at pork-chop bus stop
- Observe general traffic activity through the unprotected slip lane
- Observe general traffic patterns in right turn only lane from El Camino Real to Mission Avenue
 - Treatments are generally feasible and appropriate for the context.
 - The proposed eastbound bus-only lane utilizing the current right-turn lane is functionally possible.
 - Observations suggest a need for clearer markings and signage, particularly regarding right-turn-on-red restrictions, which may be missing or unclear.
 - Pedestrian safety improvements, such as crosswalk striping, and pedestrian signage, are supported by the current traffic pattern and road layout. We need to re-visit bollards.

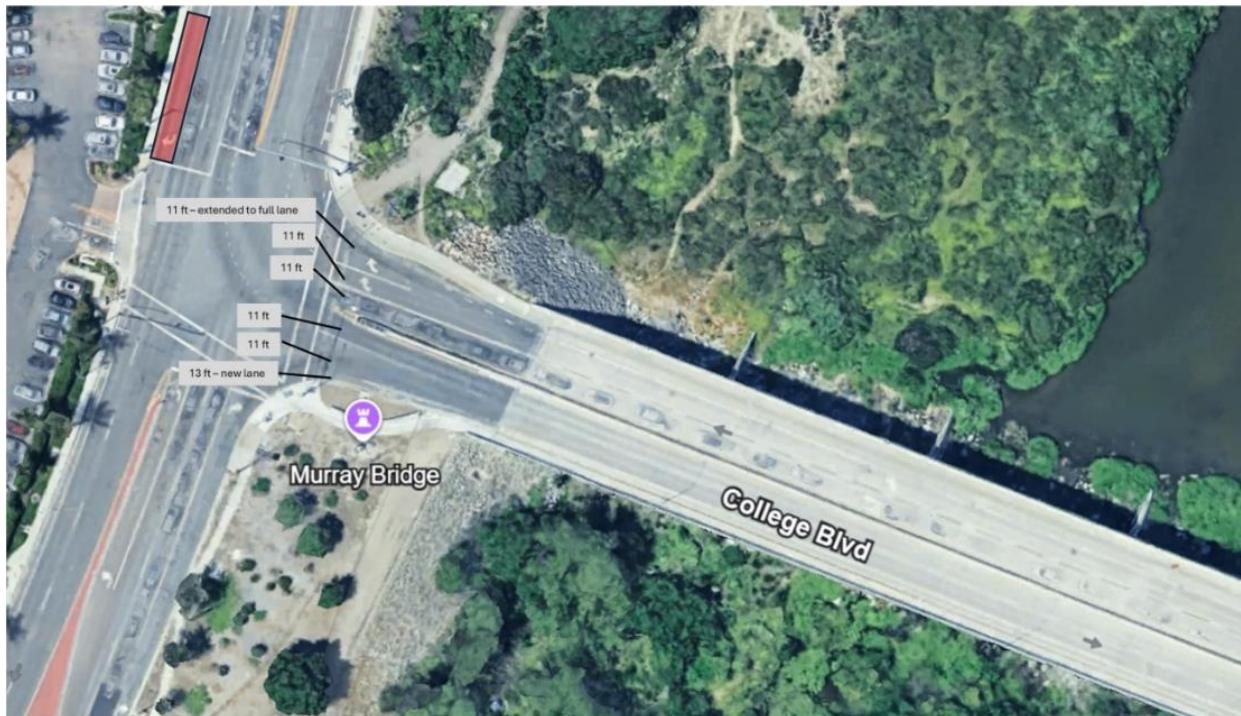
Figure 4A.2.3: Initial Recommendations for N. River Road and College Boulevard

At the time of the site visit, the PDT had initially proposed the following recommendations for this segment of the corridor:

- Observe prevalence of right turning traffic at location of proposed queue jump
- Limited opportunities exist at this intersection for meaningful infrastructure upgrades.
- The street is narrow and presents significant constraints.
- A southbound queue jump was proposed, but observations suggest it may not be impactful due to the existing traffic configuration and potential elimination of the right-turn movement.
- No significant treatments were identified as actionable or needed beyond minimal adjustments.

The proposed treatment (queue jump) is likely not impactful given the constrained street width and lack of right-turn conflicts. No major improvements are recommended.
