CHAPTER 4A

QUICK-BUILD PILOTS

4A.1.0 Introduction

4A.1.1 Broadway

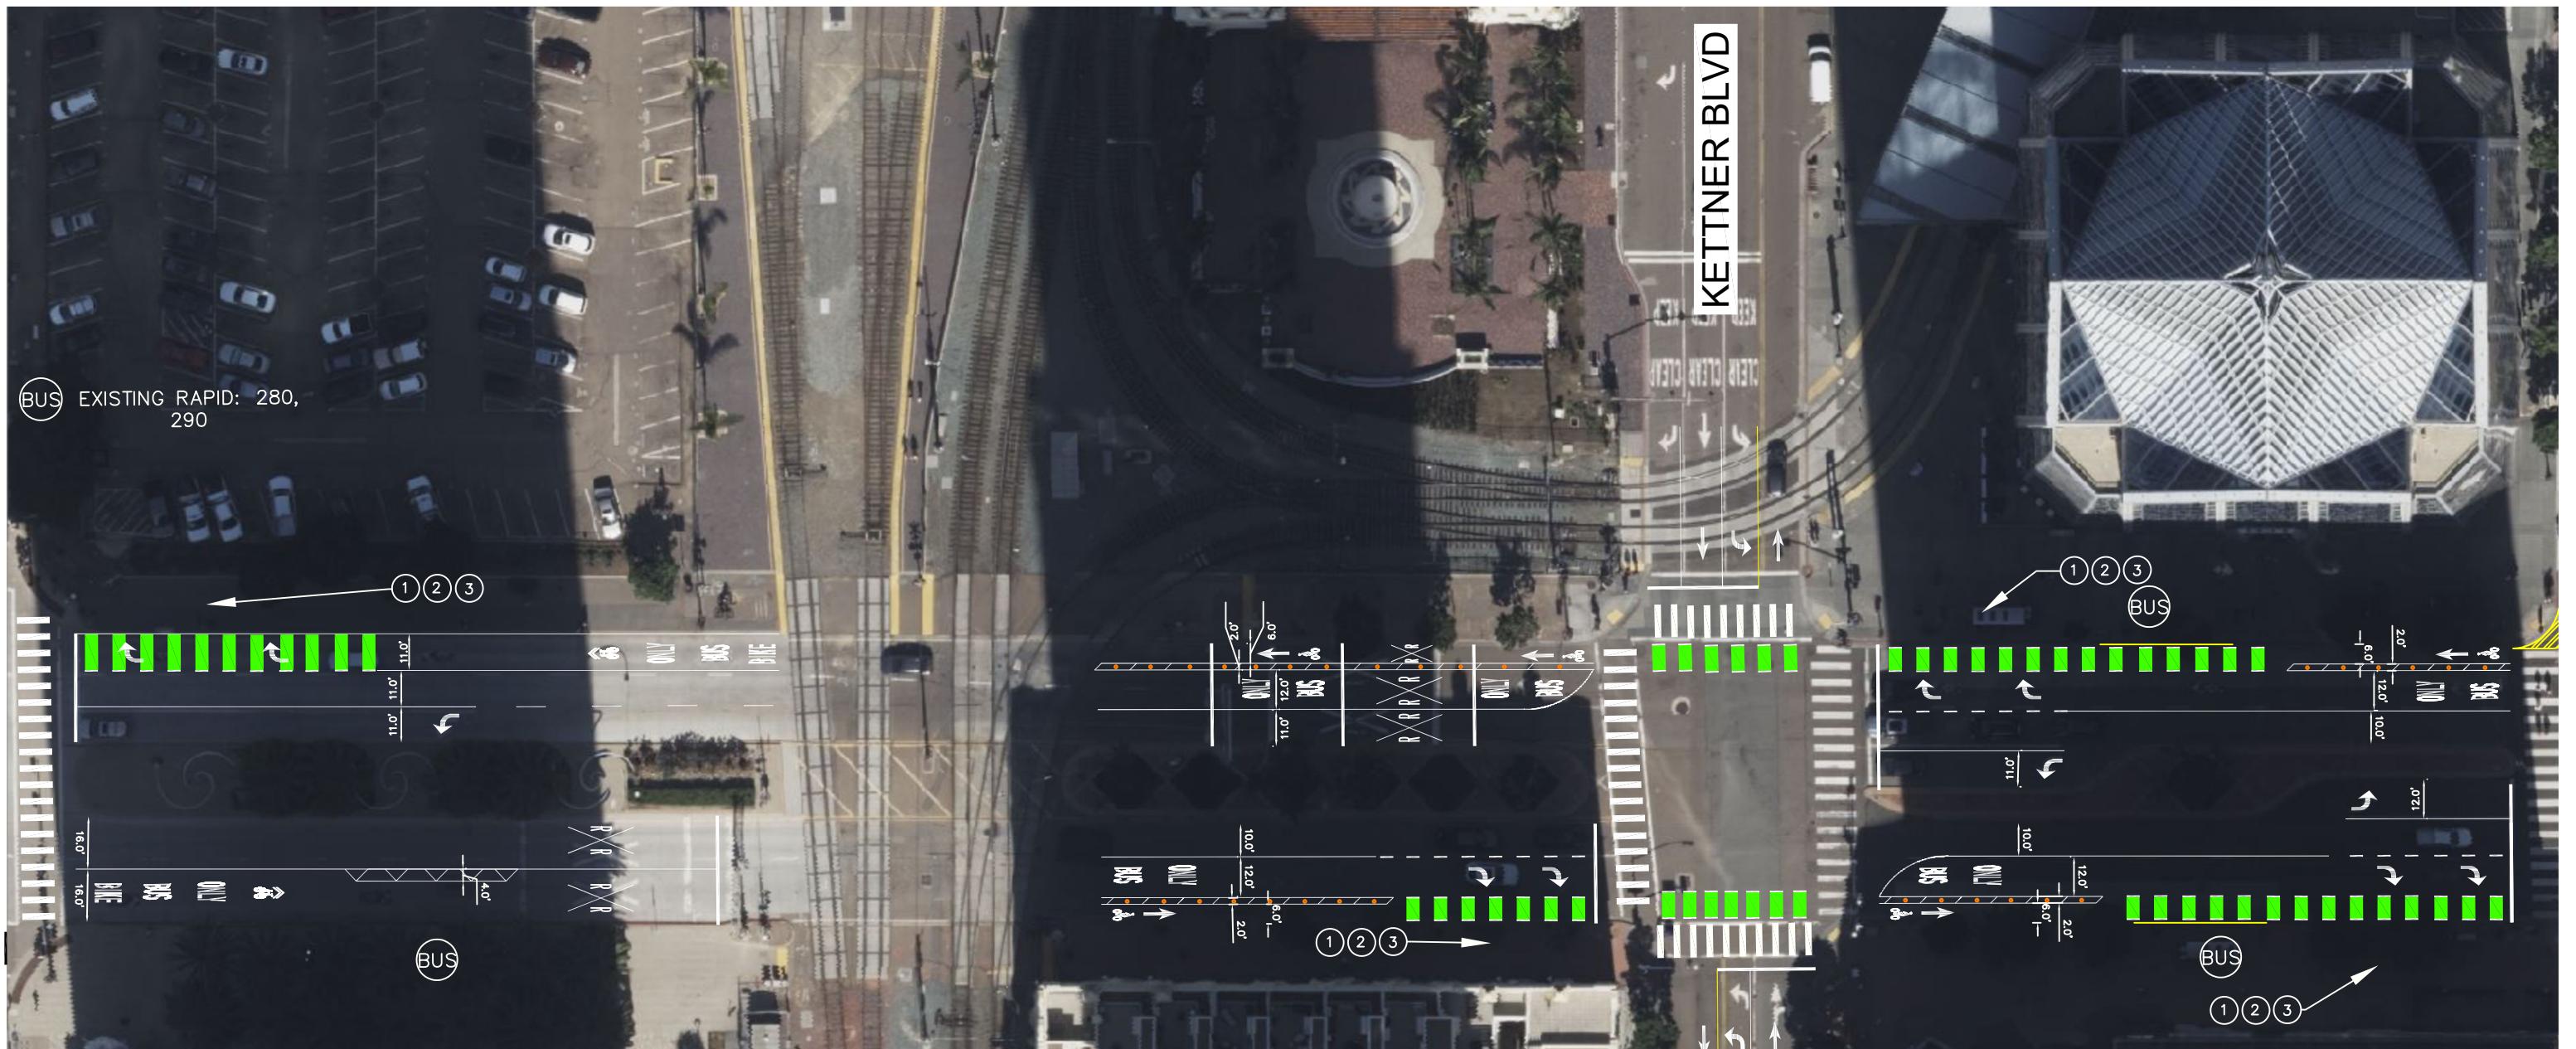
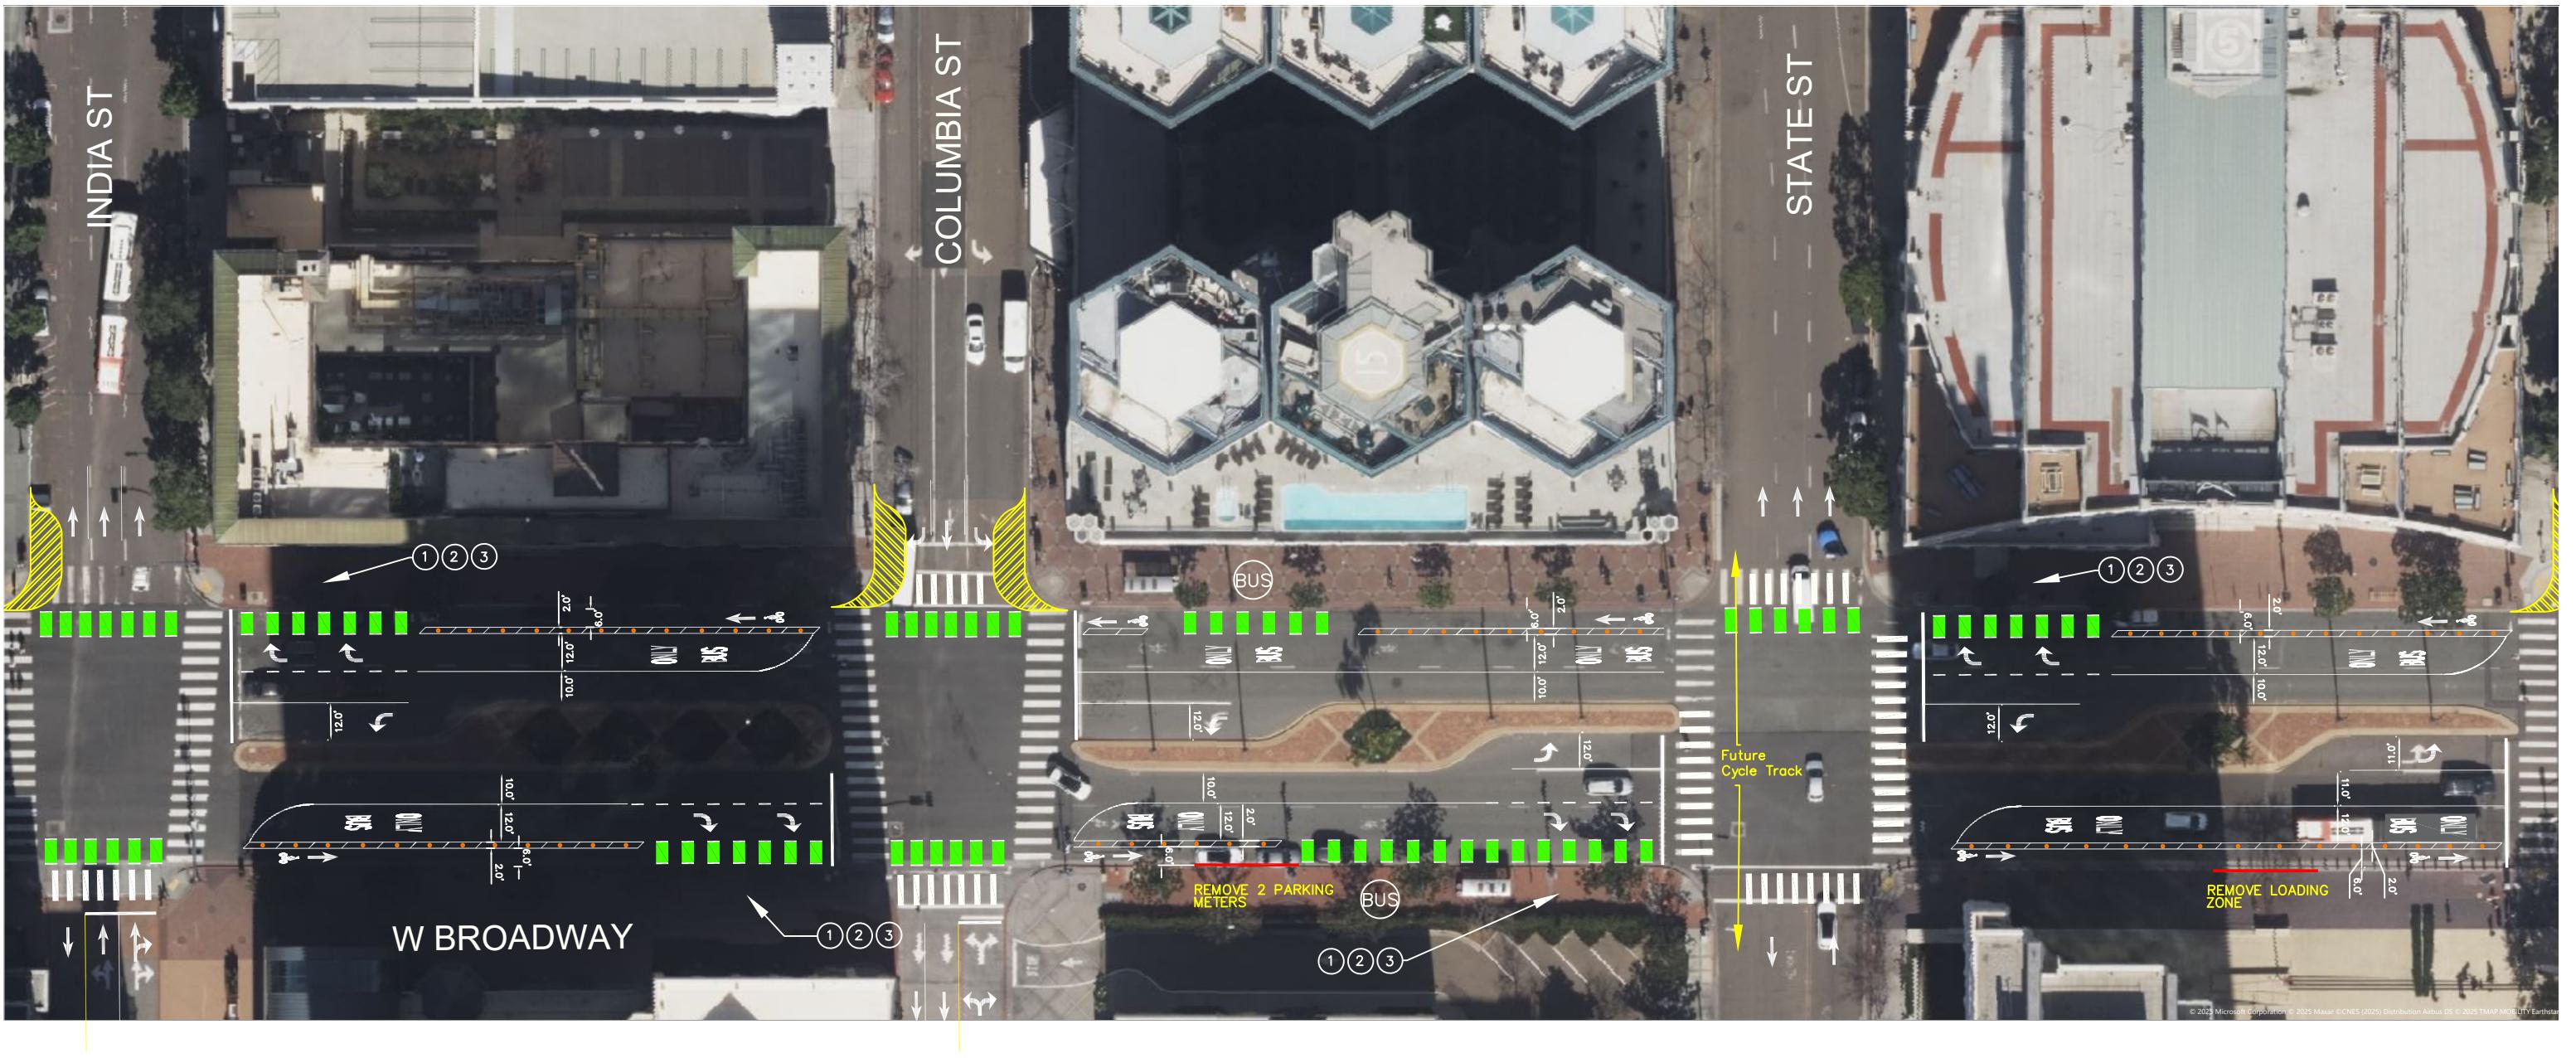
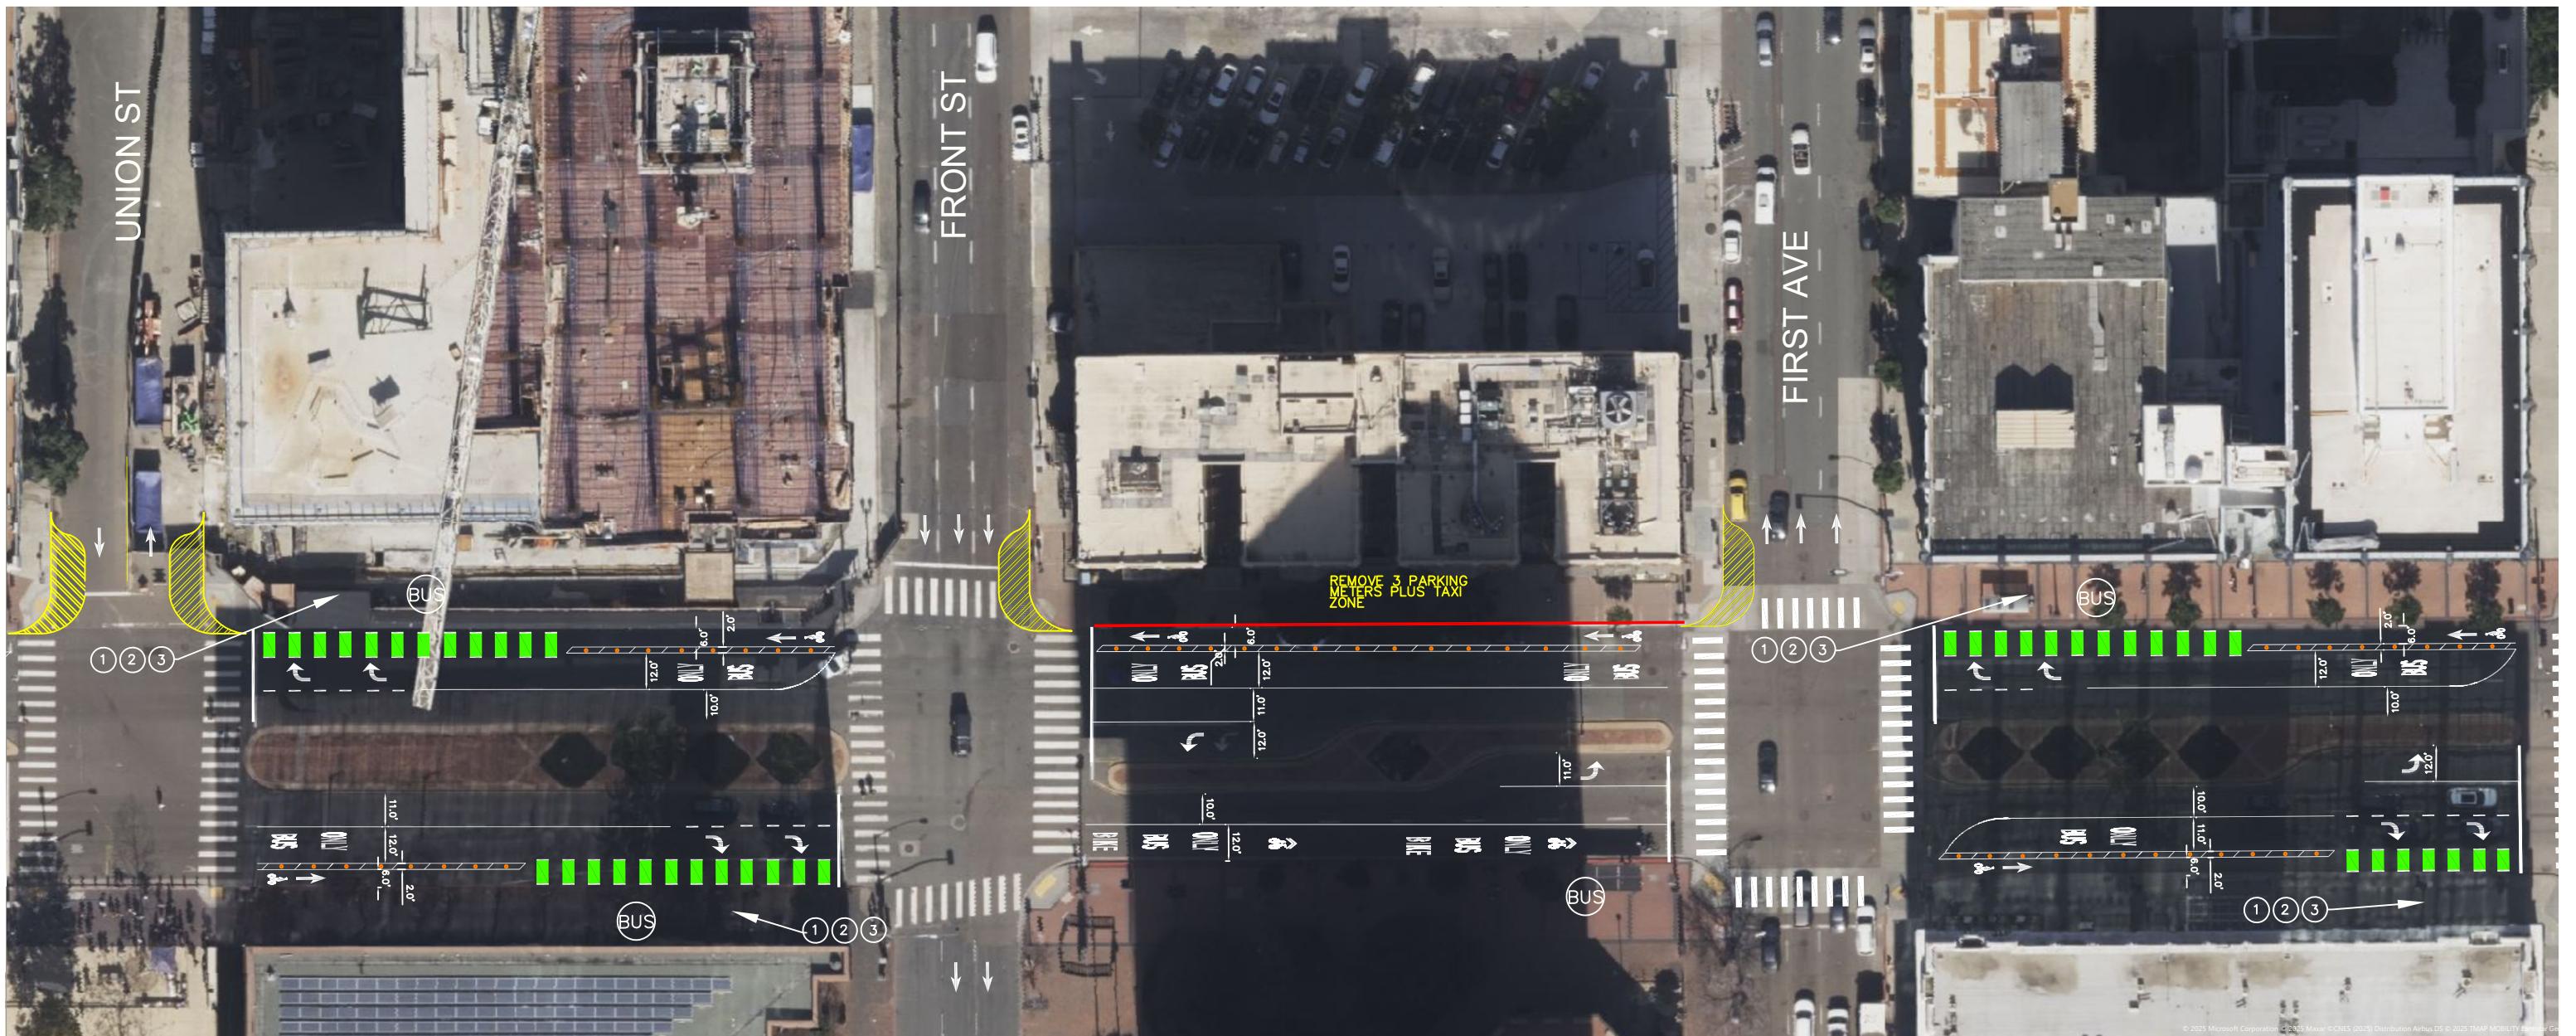
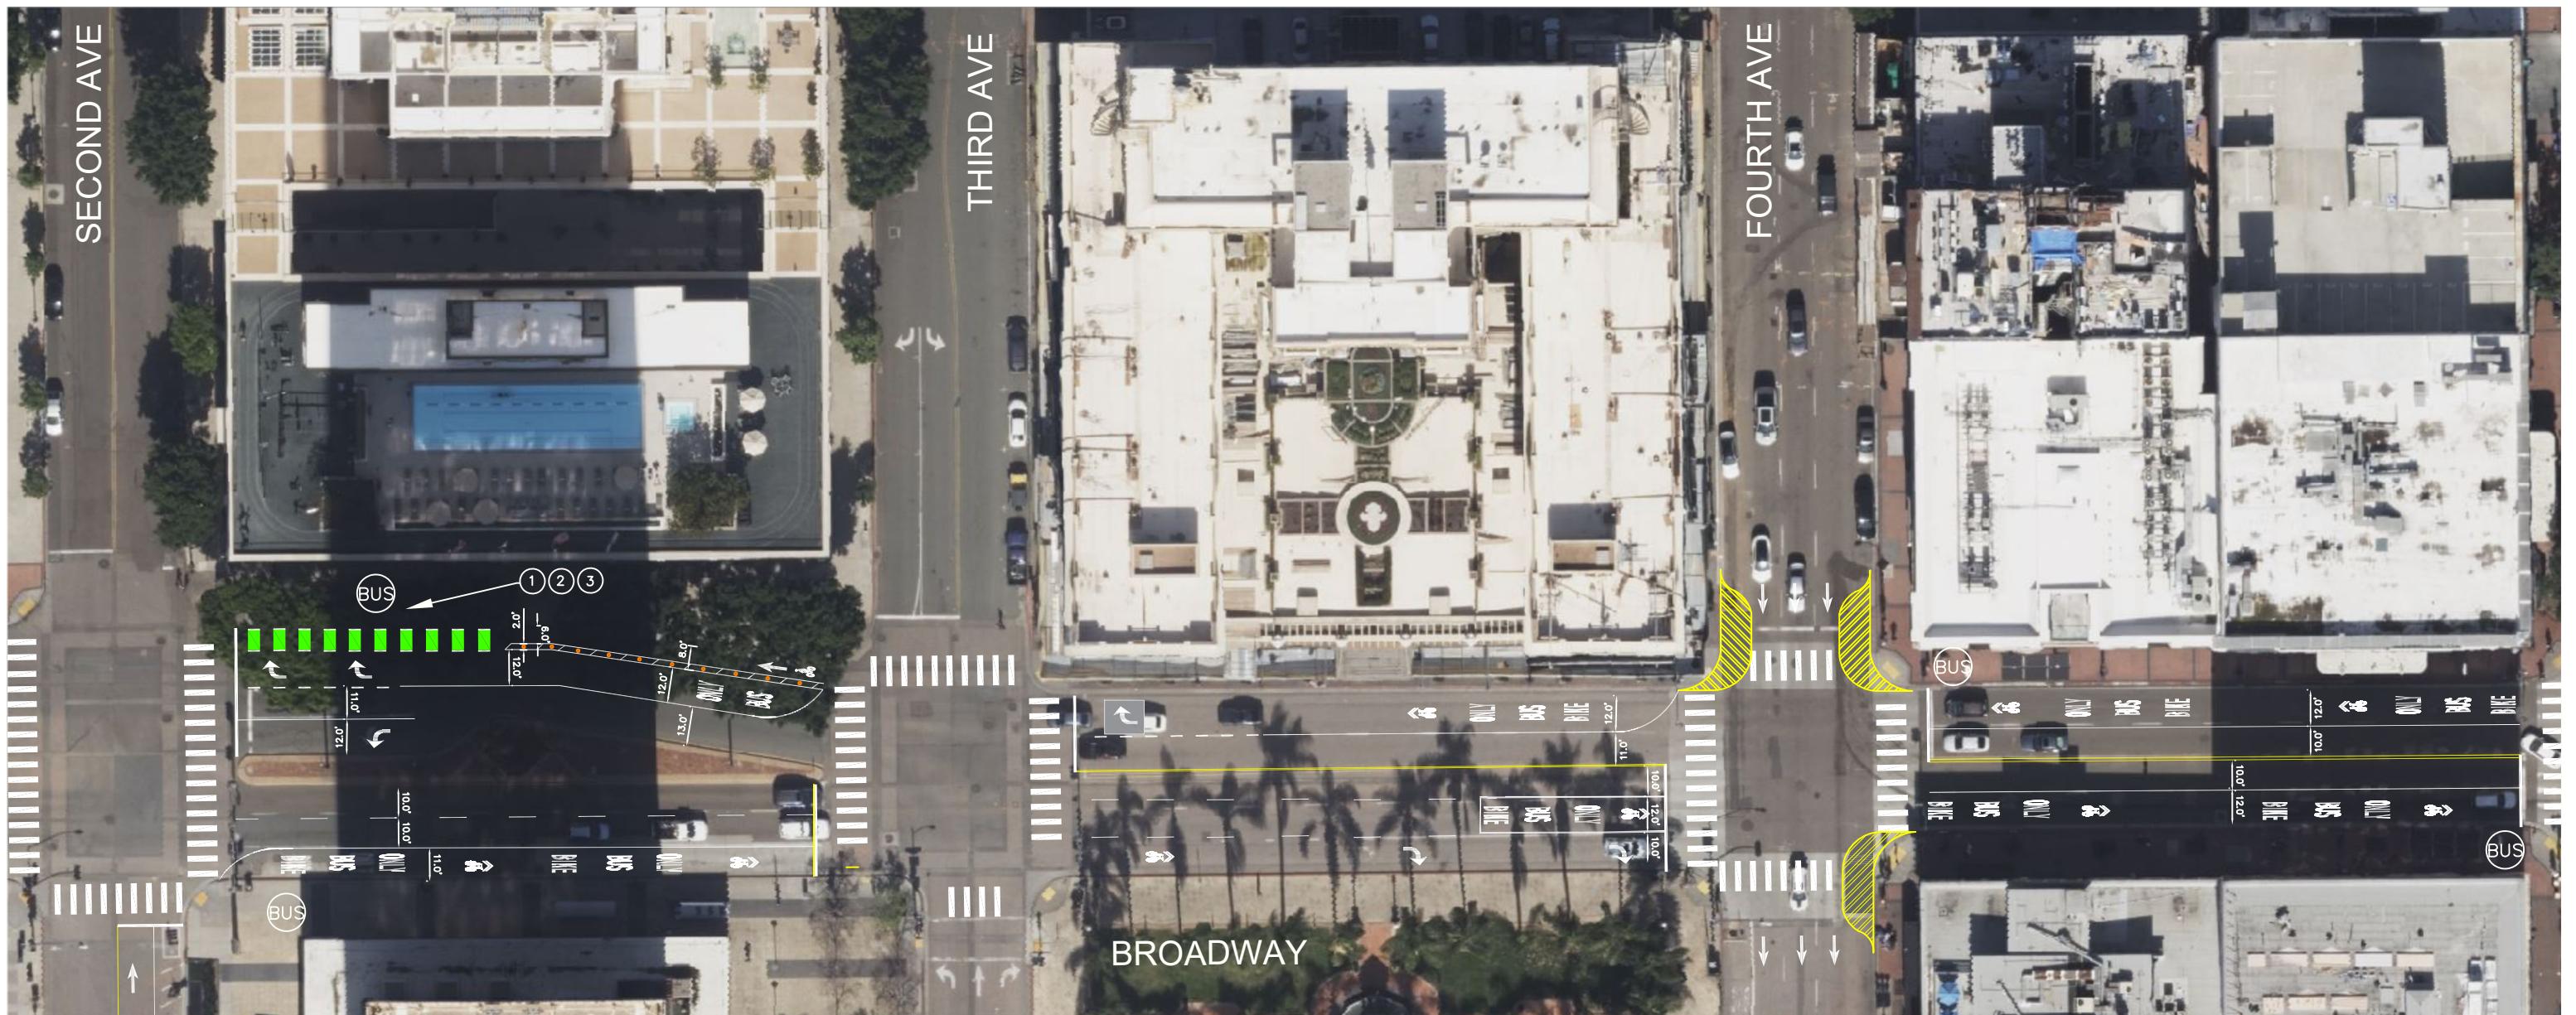
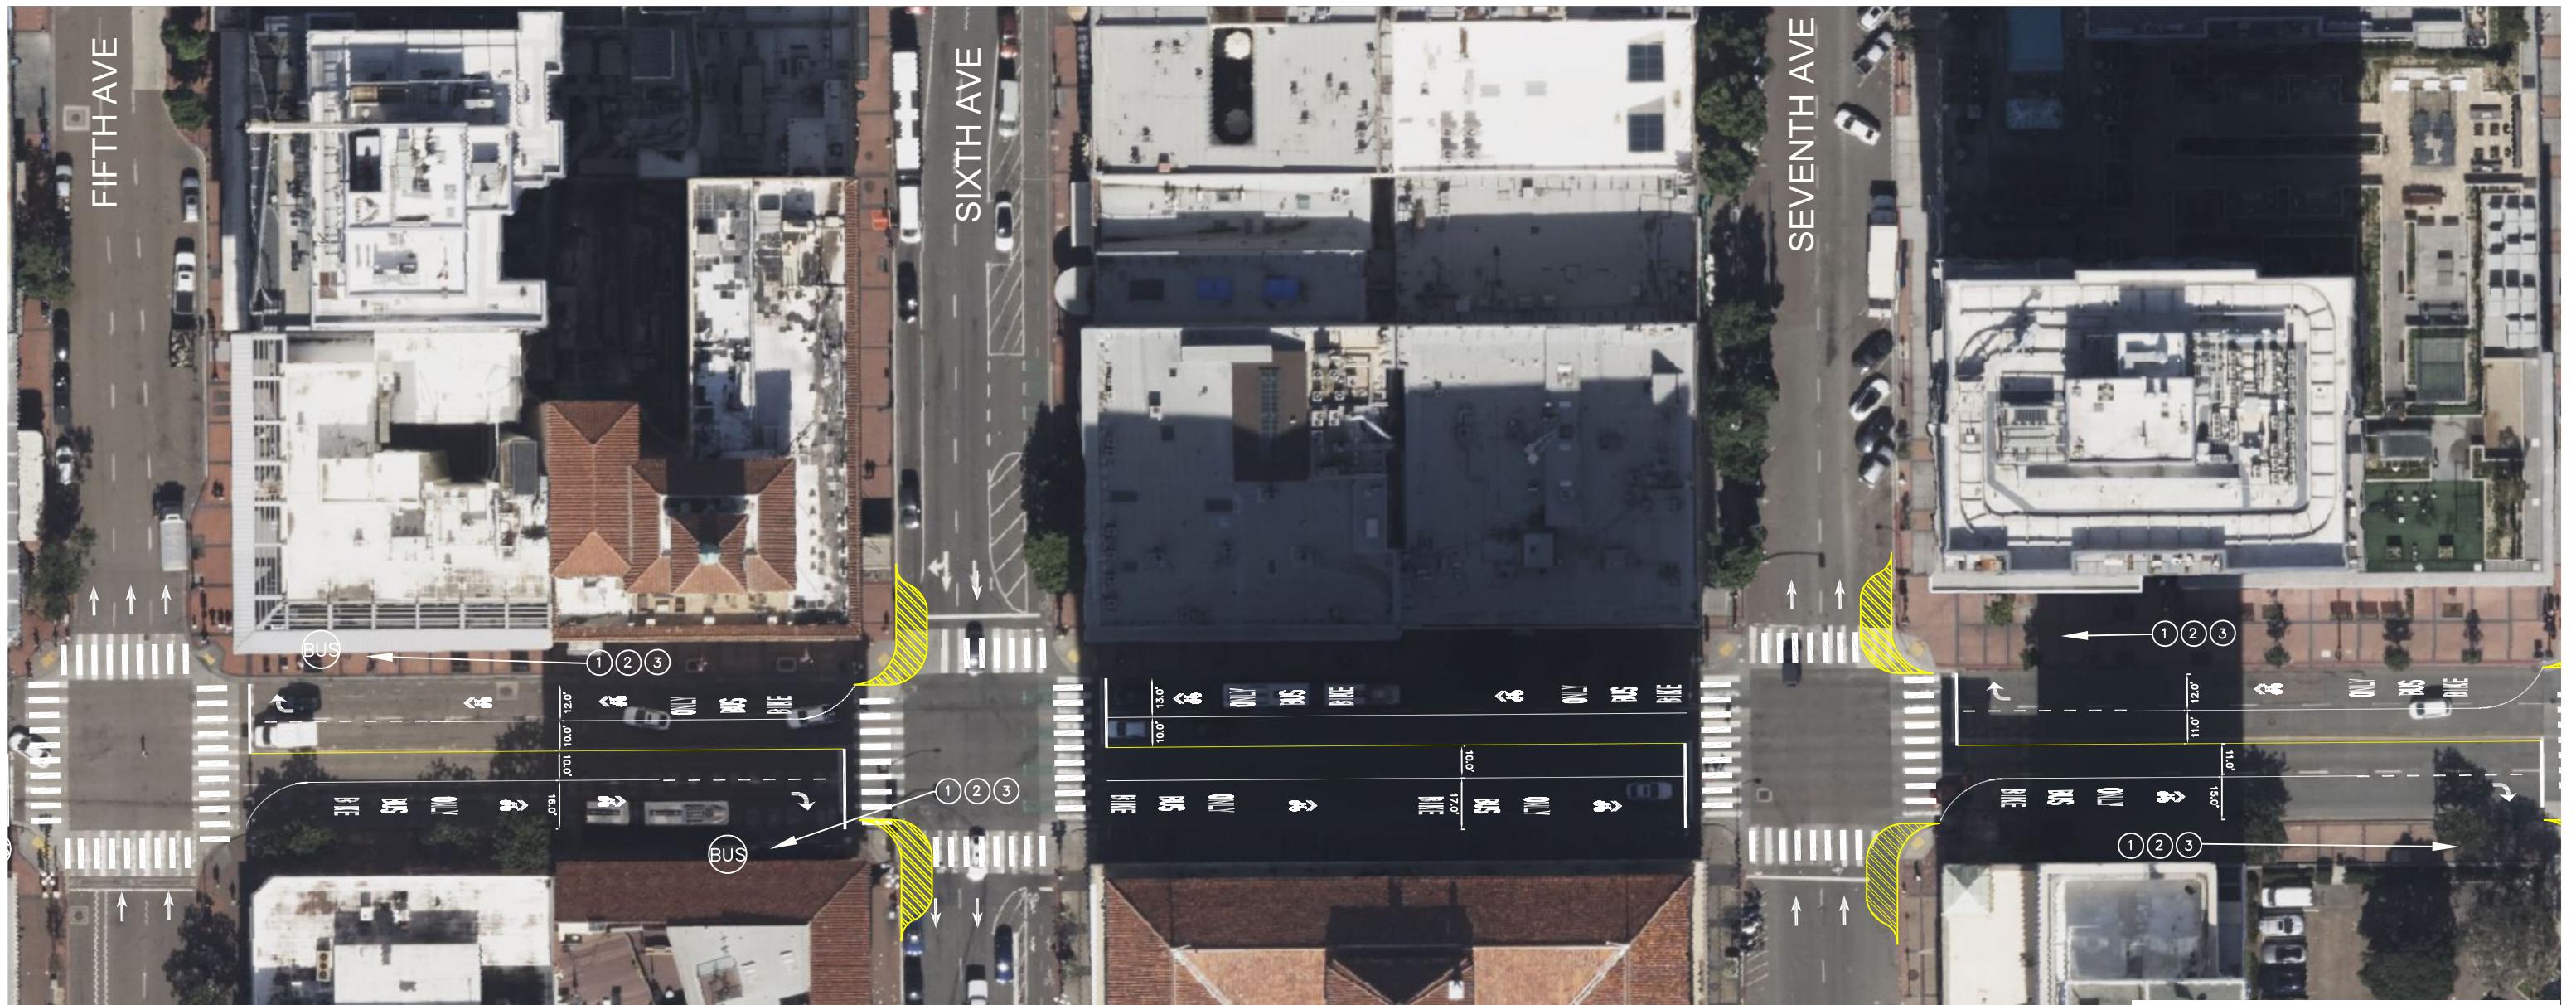
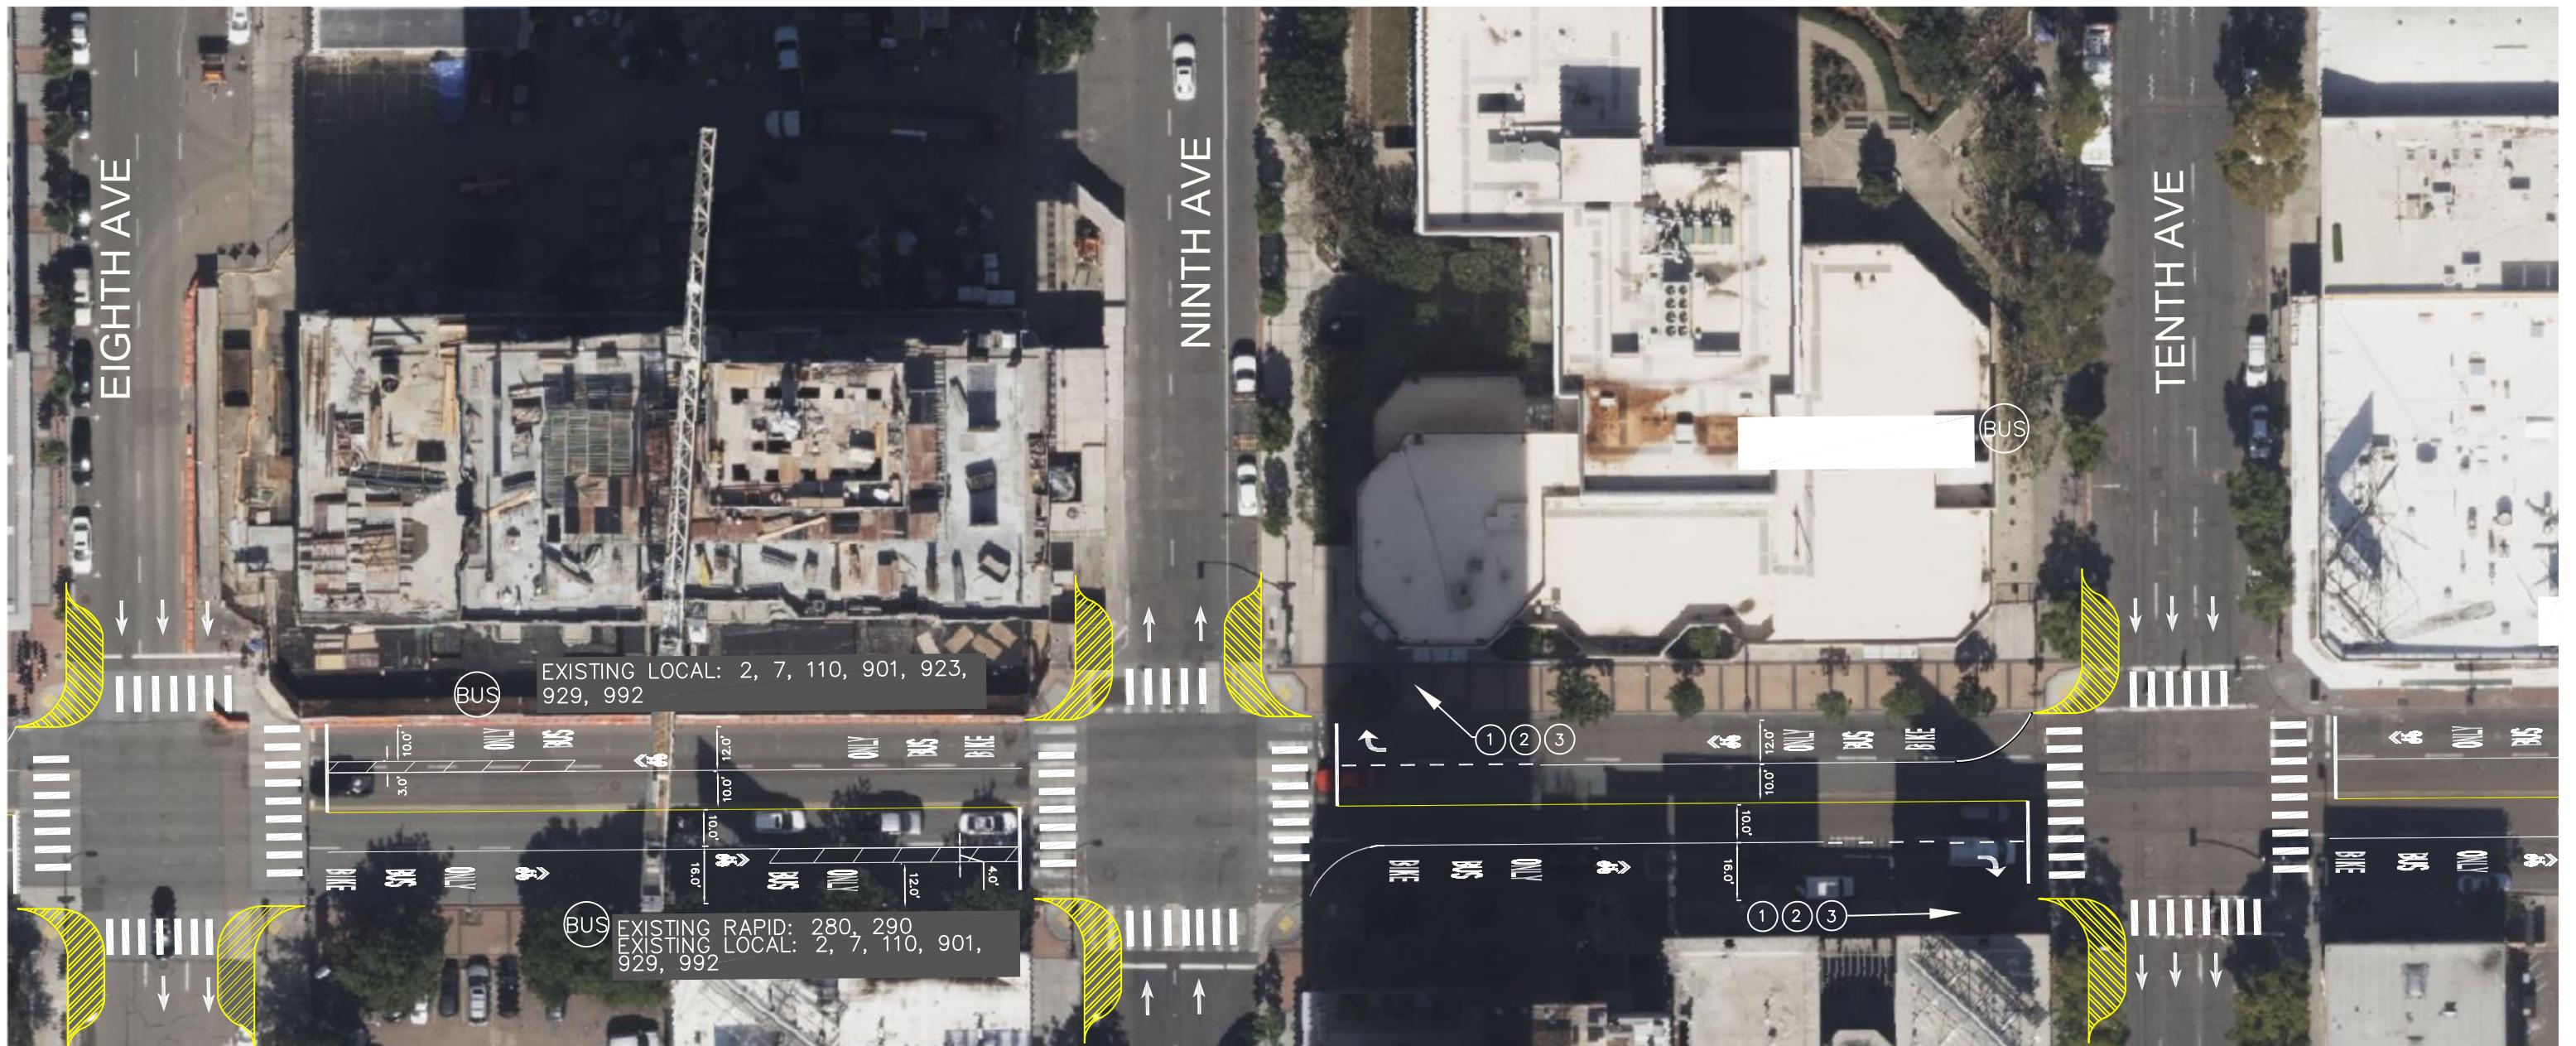
Appendix 4A.3: Broadway Pilot Designs

The following narrative describes the different design elements for each intersection that have been incorporated into the conceptual design drawings.

- **Proposed configuration:** Bus-priority lanes established in the outermost lane along the entire mile-long corridor. Lane widths vary depending on available right-of-way, but a minimum width of 12 feet is maintained, as requested by MTS. Signified via the inclusion of a "BUS ONLY" or "BUS BIKE ONLY" stencil. Where available a hashed space is created on the inside of the lane at bus-stops to give cyclists an avenue to pass stopped buses.

- **Right Turns for General Traffic:** Where right turners are permitted, right turn arrows and dashed lane lines will be used to signal to right turners and improve clarity. Additionally "Right Lane Must Turn Right Except Buses" signage is included.

- **Parking Removal:** Parking spots will need to be removed to incorporate a bus-only lane along Broadway.
 - Three metered spots and a taxi zone between 1st Ave and Front St going westbound

- **Existing conditions:** Currently, no dedicated bicycle infrastructure exists along the corridor, forcing cyclists to either mix with traffic or, as frequently observed, ride on sidewalks.
- **Proposed configuration:** Standard 8-foot-wide (6-foot lane, with 2-foot margin) bicycle lanes with painted buffers adjacent to the curb, where lane widths allow. This currently means that the separated bike lanes would exist from Santa Fe Depot to Third Avenue.
- **Benefits:** Addresses safety concerns for cyclists currently mixing with traffic or riding on sidewalks and represents a significant improvement over current conditions
- **Safety features:** Mixing zones will occur at right turns and bus stops, so green conflict striping is included to alert cyclists, bus operators, and drivers to these interactions.
