CHAPTER 4A

QUICK-BUILD PILOTS

4A.1.0 Introduction

4A.1.1 Broadway

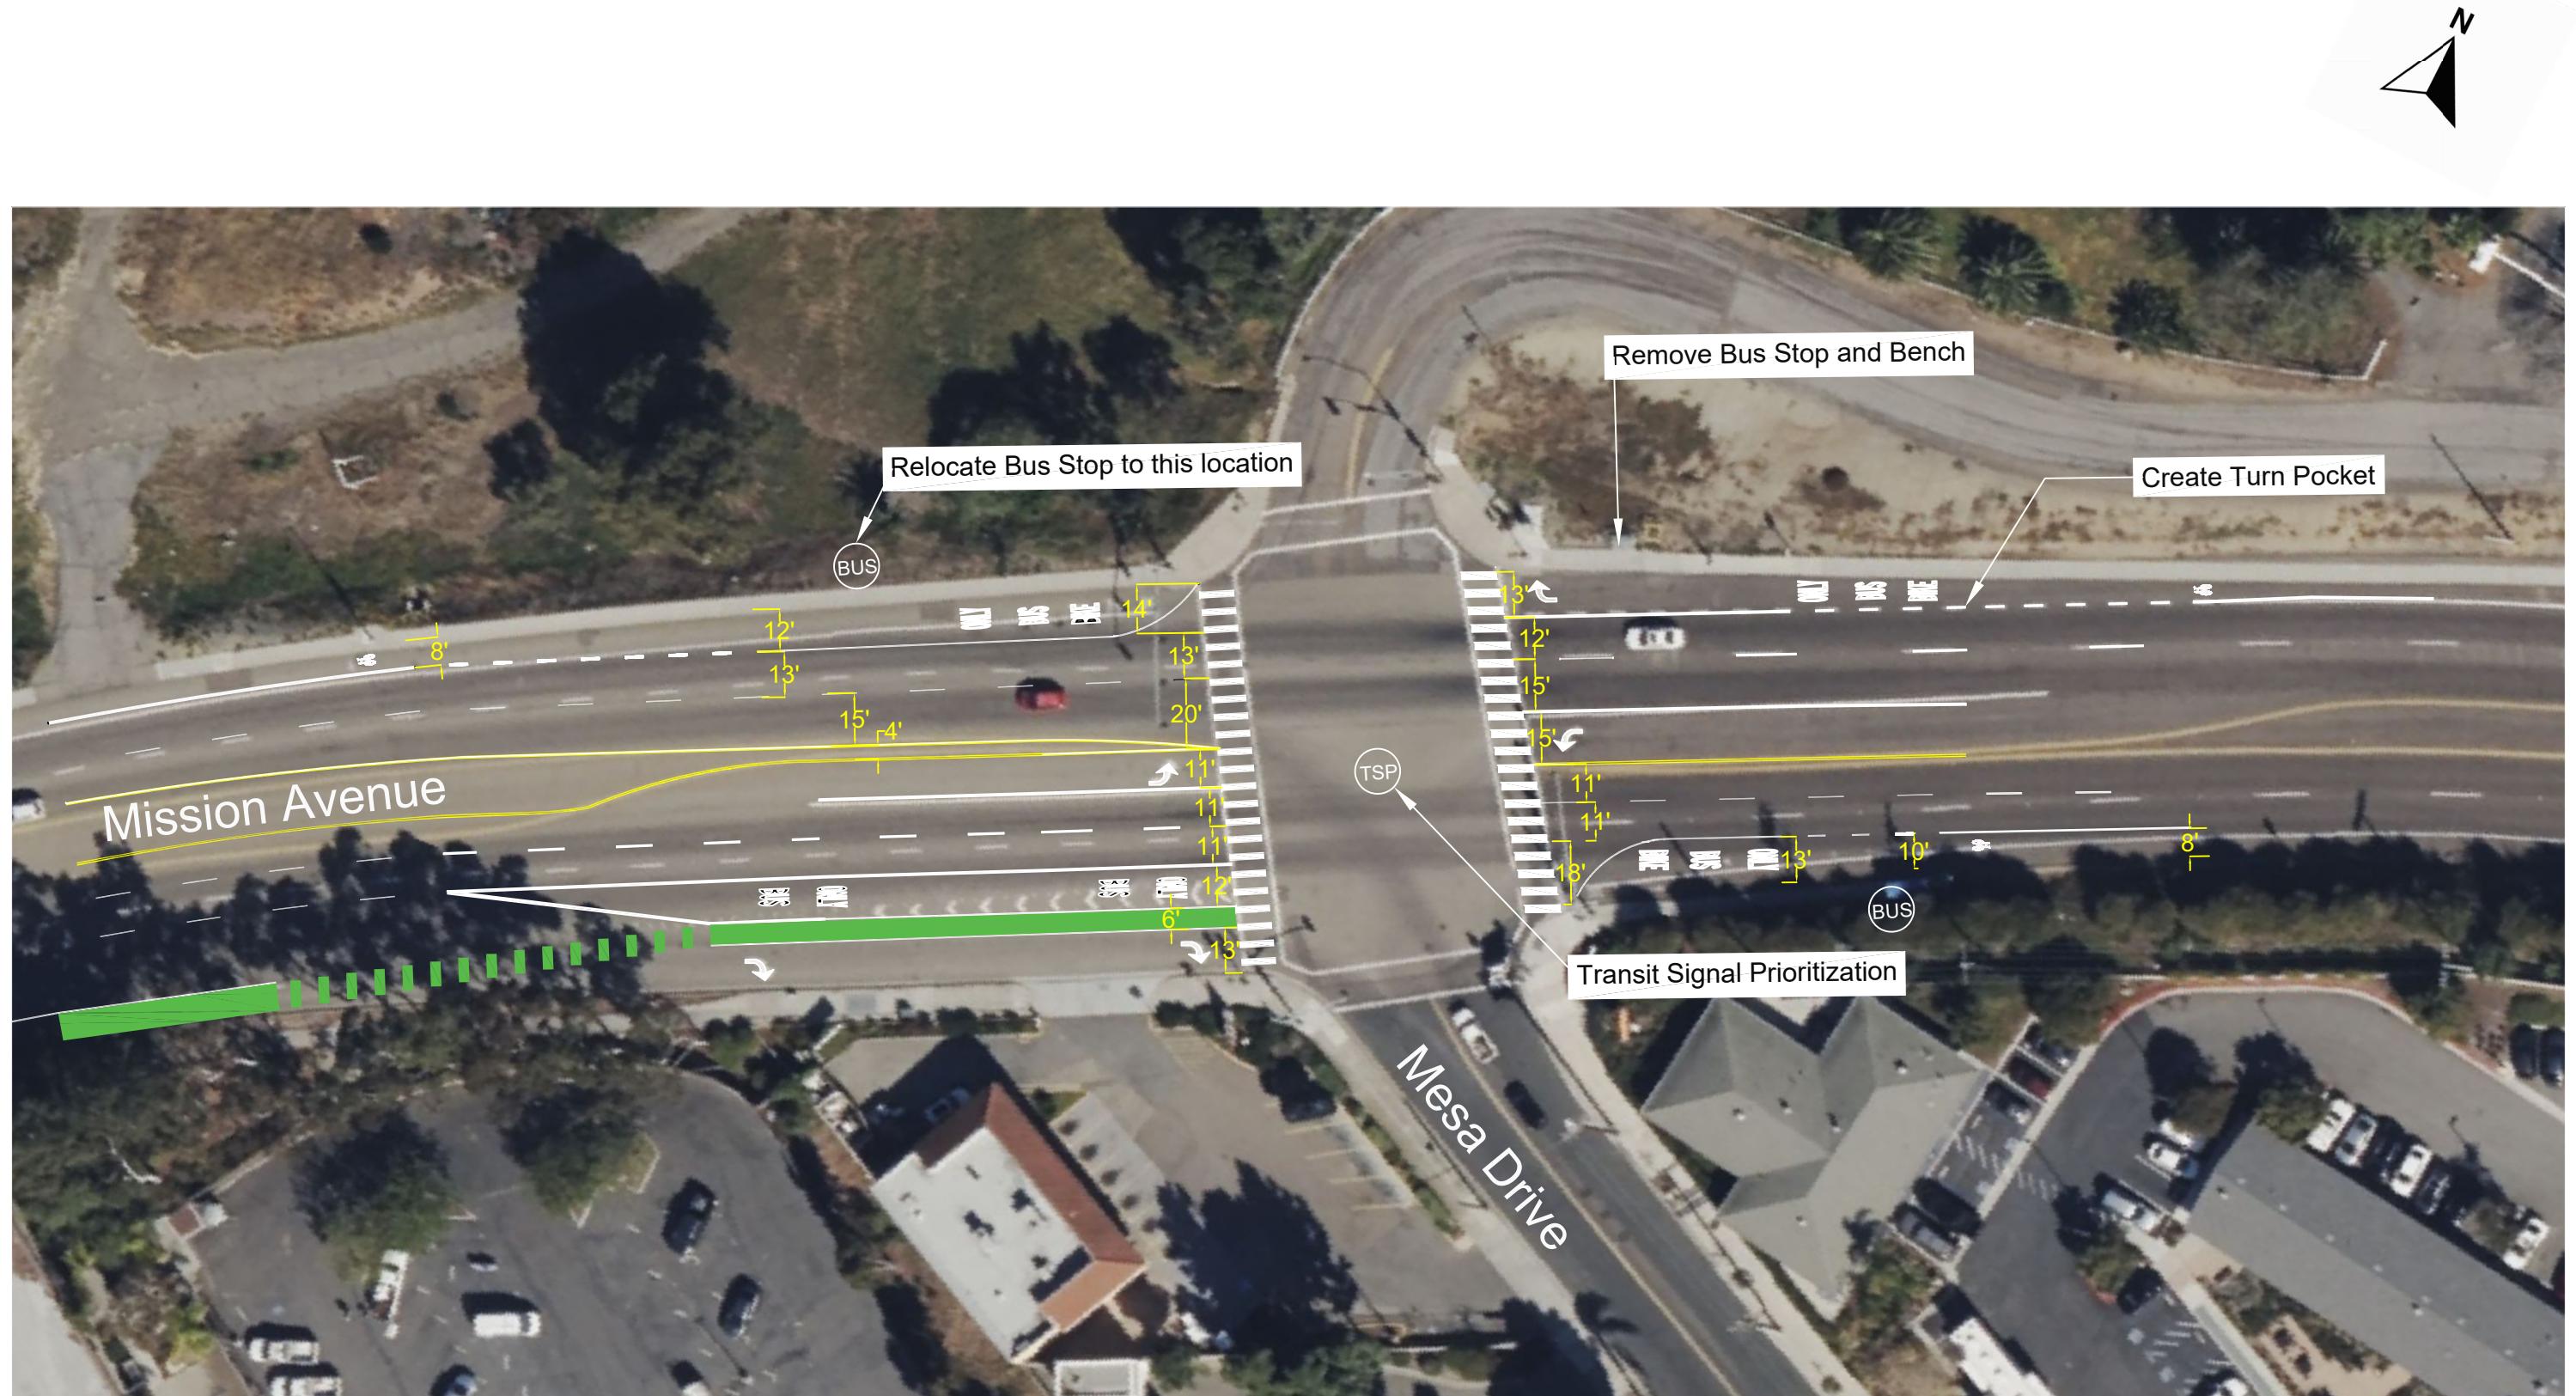
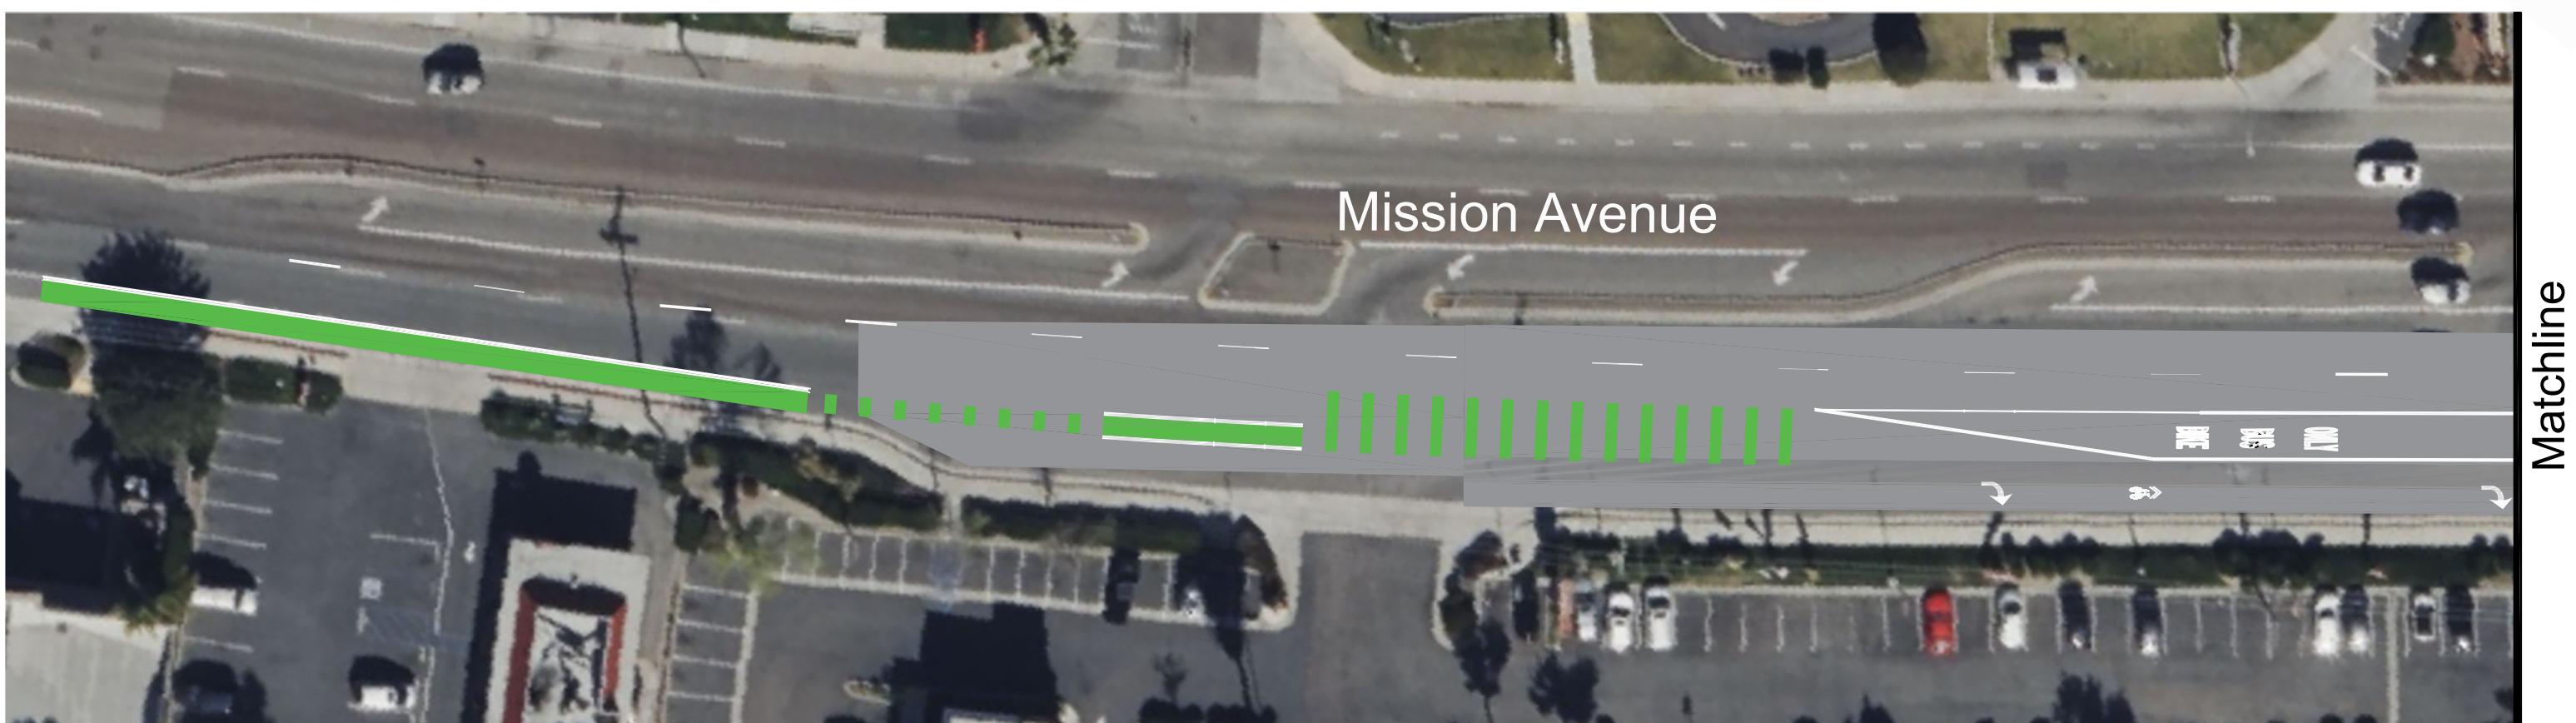
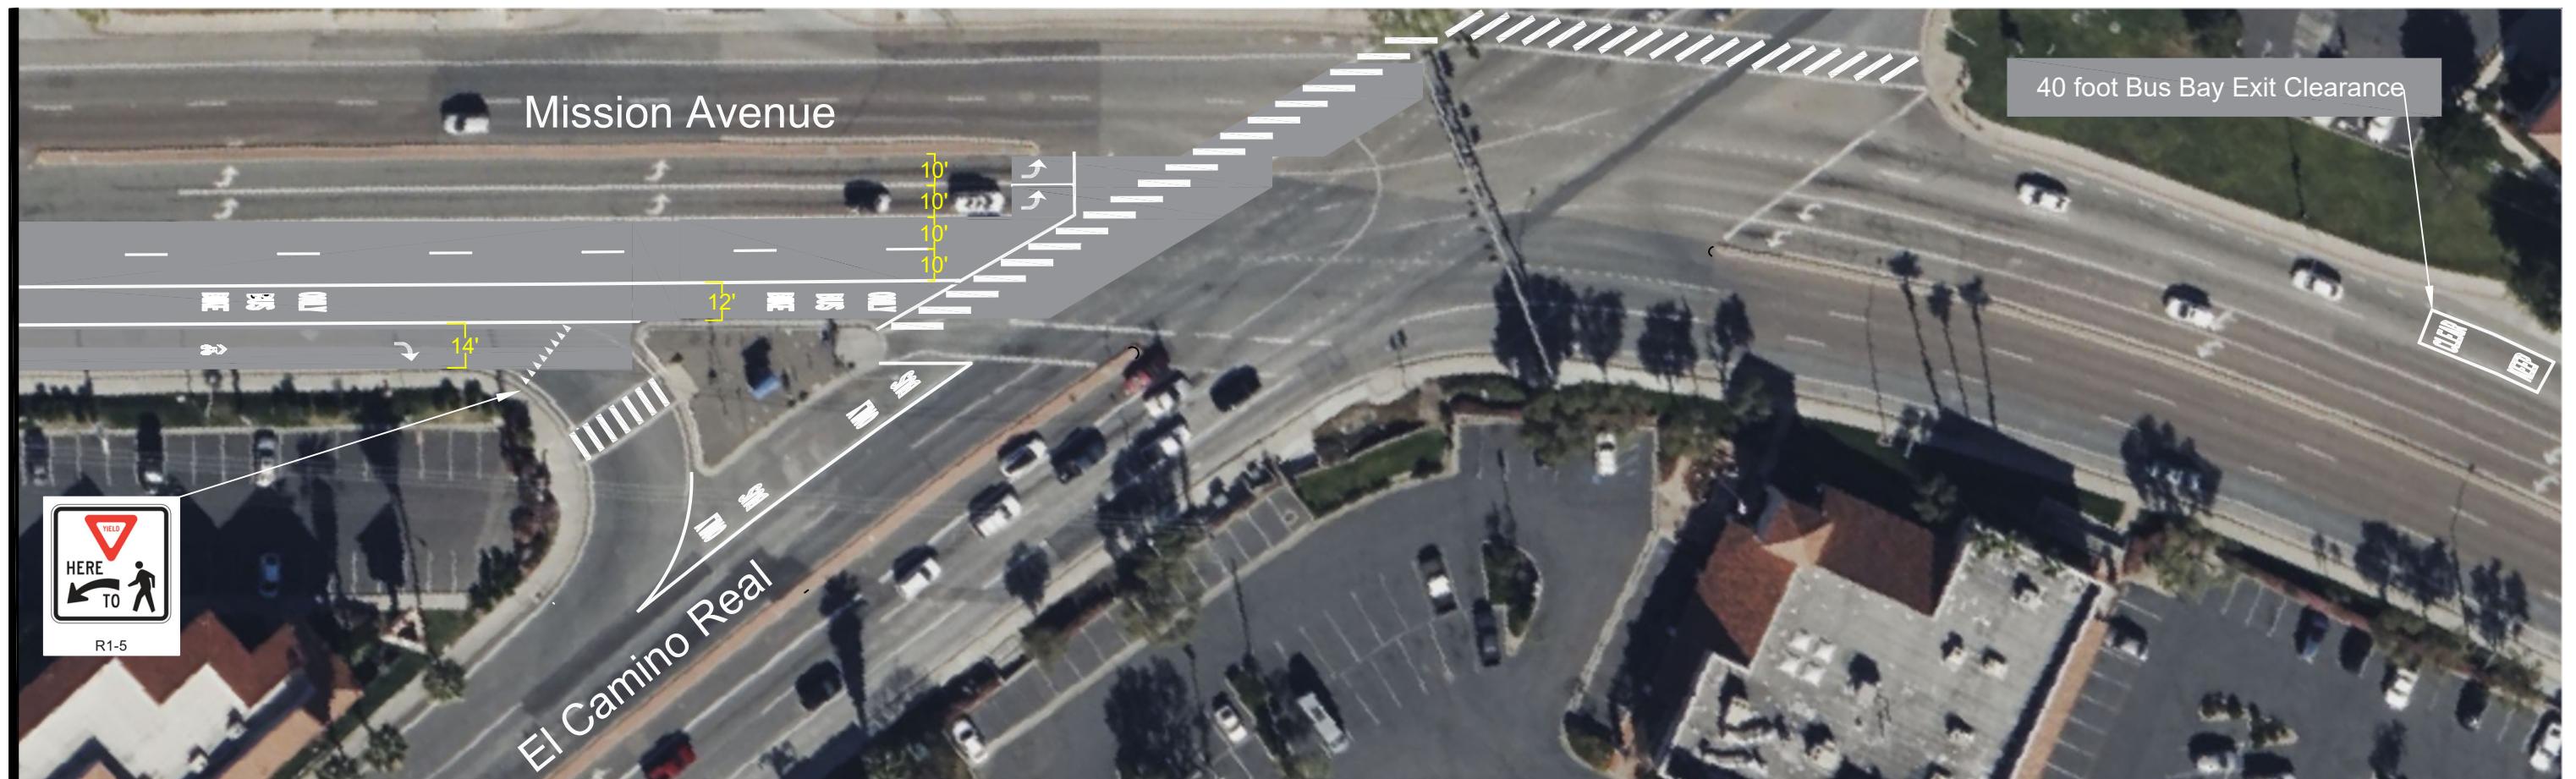
Appendix 4A.4: Oceanside Pilot Designs

The following narrative describes the different design elements that have been incorporated into the conceptual design drawings.

- **Existing conditions:** Currently, buses queue with general traffic at the light, often facing delays during peak periods before reaching the far-side bus stop. There is an existing median separating forward traffic lanes and a right-turning lane.
- **Proposed configuration:** Convert median into dedicated bus queue jump lane by taking away some excessive width from the existing four lanes to create a 12-foot bus lane, as requested by NCTD. A sharrow is included to allow cyclist to use this zone as well.
- **Benefit:** This allows buses to bypass general traffic and proceed directly to the stop.

- **Existing conditions:** At present, buses pull to the curb to serve a near-side stop, then they must merge back into traffic, causing delays.
- **Proposed configuration:** Move the bus-stop to the far side of the intersection, with an existing bicycle lane being converted into a turning pocket buses can also use as a queue jump lane. A sharrow is included to allow cyclist to use this zone as well.
- **Benefit:** This enables buses to skip the traffic queue while still serving riders.
- **Signal enhancement:** At both queue jumps, a small bus signal may be installed to give buses a leading signal over general traffic. Initially, this would be a simple timed signal but could later be upgraded once a corridor-wide TSP system is in place.

- **Existing conditions:** Existing crosswalks, currently marked only by white border striping
- **Proposed configuration:** Crosswalks at the intersection are enhanced with bold horizontal striping for higher visibility to improve pedestrian safety and bus stop access

- **Existing conditions:** Currently, buses queue with general traffic at the intersection, an area NCTD has noted experiences heavy congestion during peak periods, before pulling into a bus stop located on a small island. After serving the stop, buses must merge back into traffic to continue through the intersection, often causing delays.
- **Proposed configuration:** A small bus only lane will be added at the bus stop, by reducing the size of other traffic lanes. This lane is signified through the inclusion of "BUS ONLY" stencils. Additionally buses will be permitted to use an existing right-turning slip lane to skip traffic and approach this bus-only lane. A sharrow is included to allow cyclist to use this zone as well.
- **Benefits:** Allows buses to bypass queued traffic and move directly to the front of the line.

- **Existing conditions:** Currently on the unique "pork-chop" island feature of the intersection, there is an unmarked lane that is used by the 309 bus to pull up to a southbound bus-stop location.
- **Proposed configuration:** Lane has been marked with "BUS ONLY" stencils to further designate the lane for buses.
- **Benefits:** Formalizes existing bus operations and provides clear designation for transit priority.

- **Existing conditions:** Currently, buses use a dedicated pullout to serve a westbound stop but face delays merging back into traffic.
- **Proposed configuration:** "KEEP CLEAR" markings added to the curbside lane at the Westbound Mission Avenue and El Camino Real bus stop, reinforced with "KEEP CLEAR" stencils and white striping.
- **Benefits:** The keep-clear zone provides a dedicated space for buses to re-enter the lane after serving the stop.
