**2019 REGIONAL BEACH
MONITORING PROGRAM**

ANNUAL REPORT

SANDAG
2019 REGIONAL BEACH
MONITORING PROGRAM

Coastal Frontiers Corporation

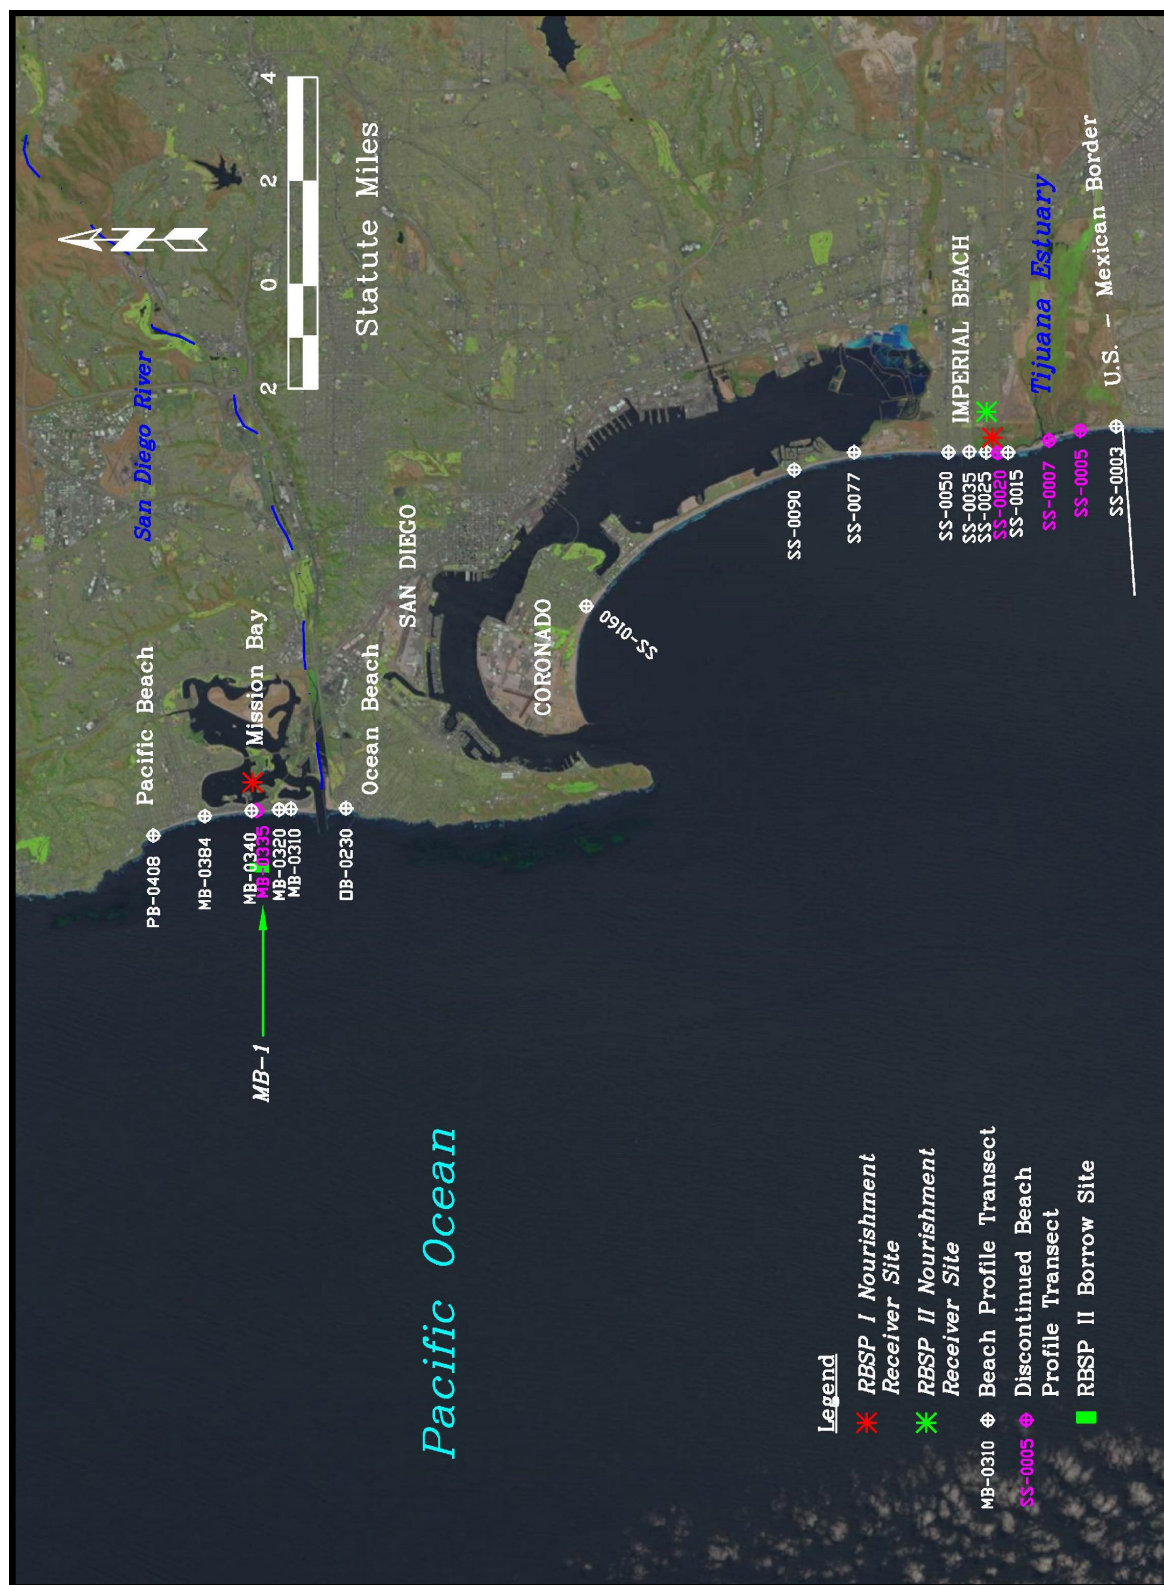
Figure 12a. Beach Profile Transects in the Silver Strand and Mission Beach Littoral Cells

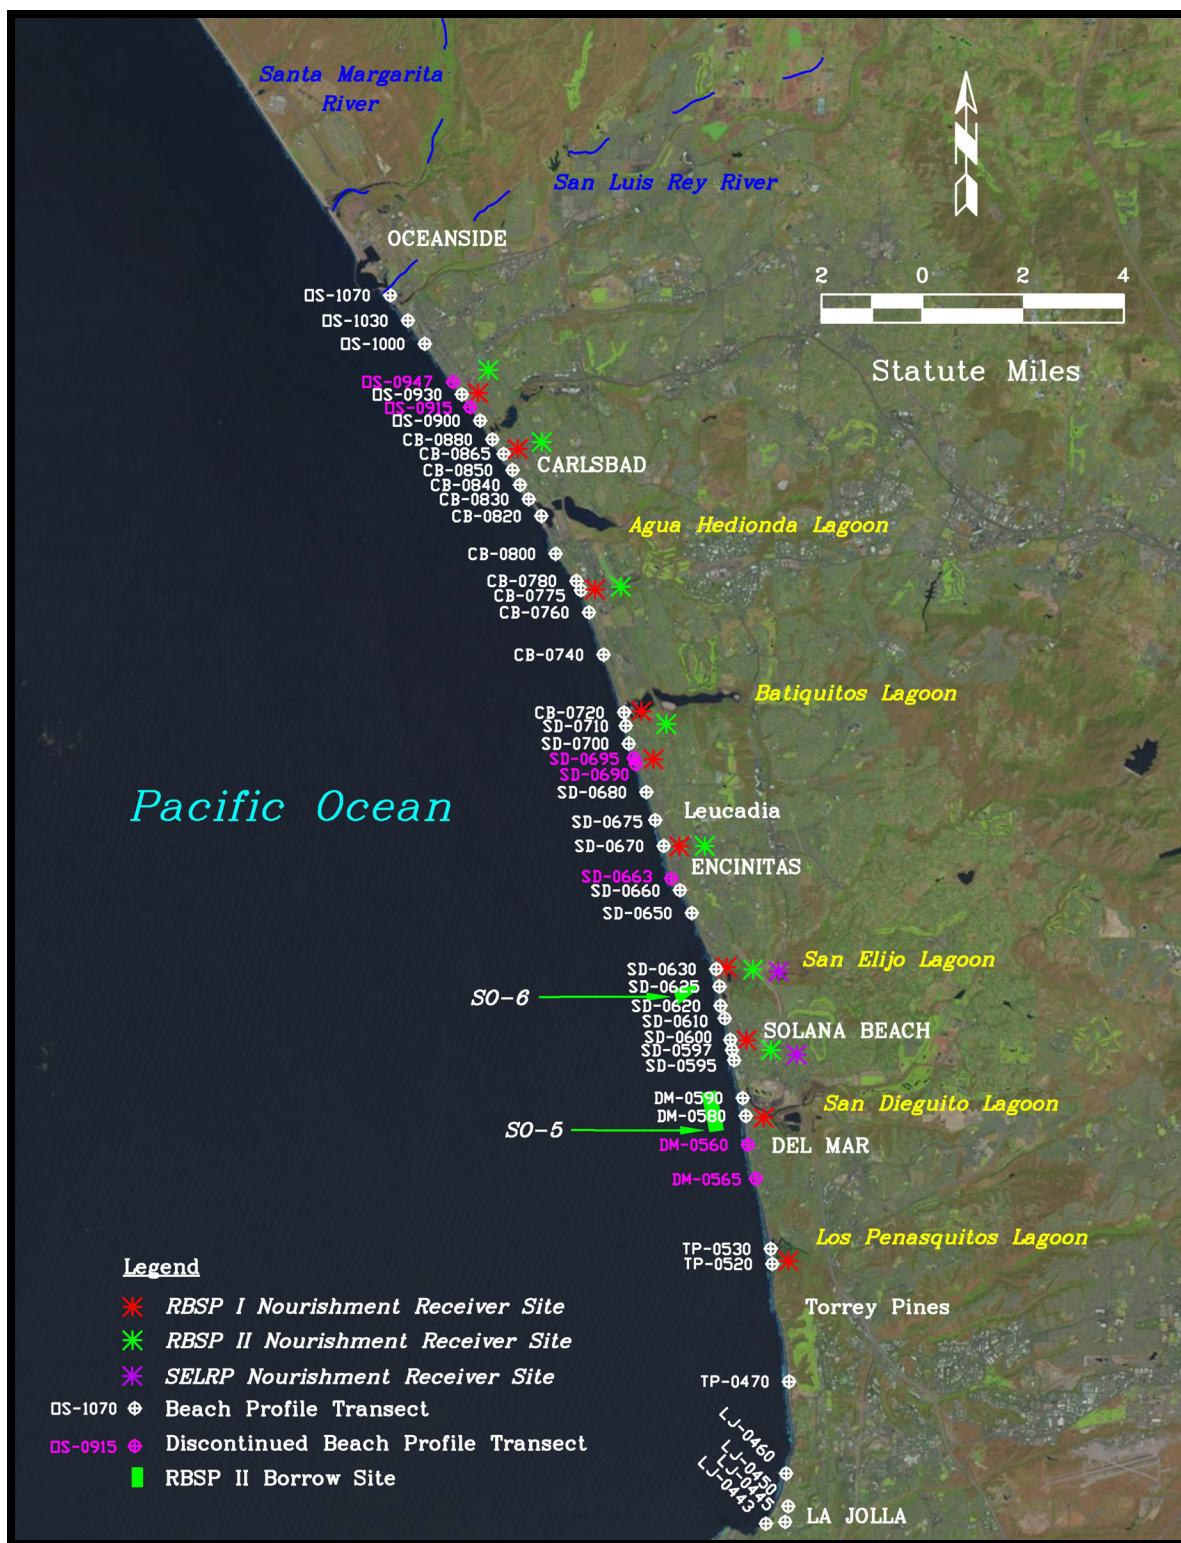
Figure 12b. Beach Profile Transects and Lagoon Entrances in the Oceanside Littoral Cell

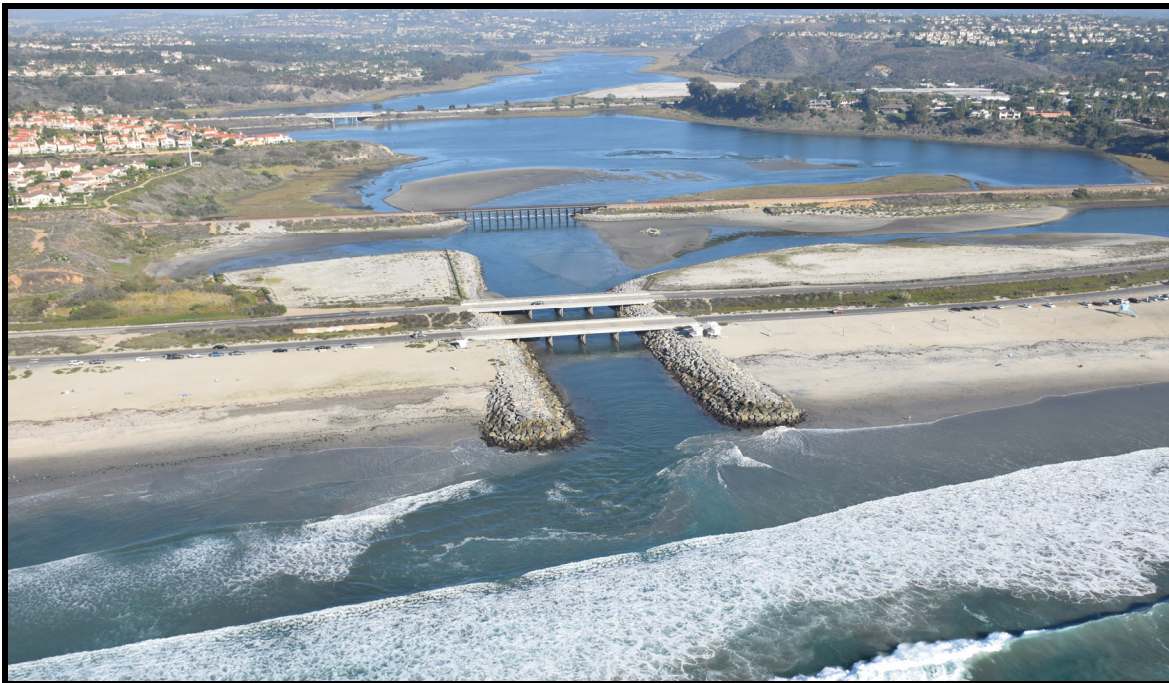
Plate 2. Batiquitos Lagoon Entrance, October 2015

Prior to 1994, the entrance to Batiquitos Lagoon was unstabilized and prone to frequent closure (SANDAG, 1999b). As part of the Batiquitos Lagoon Restoration Project conducted between 1994 and 1997, two rubble mound jetties were constructed at the entrance and 1.8 million cy of sediment were dredged from the wetlands. Plate 2 shows the condition of the Batiquitos Lagoon entrance channel in October 2015.

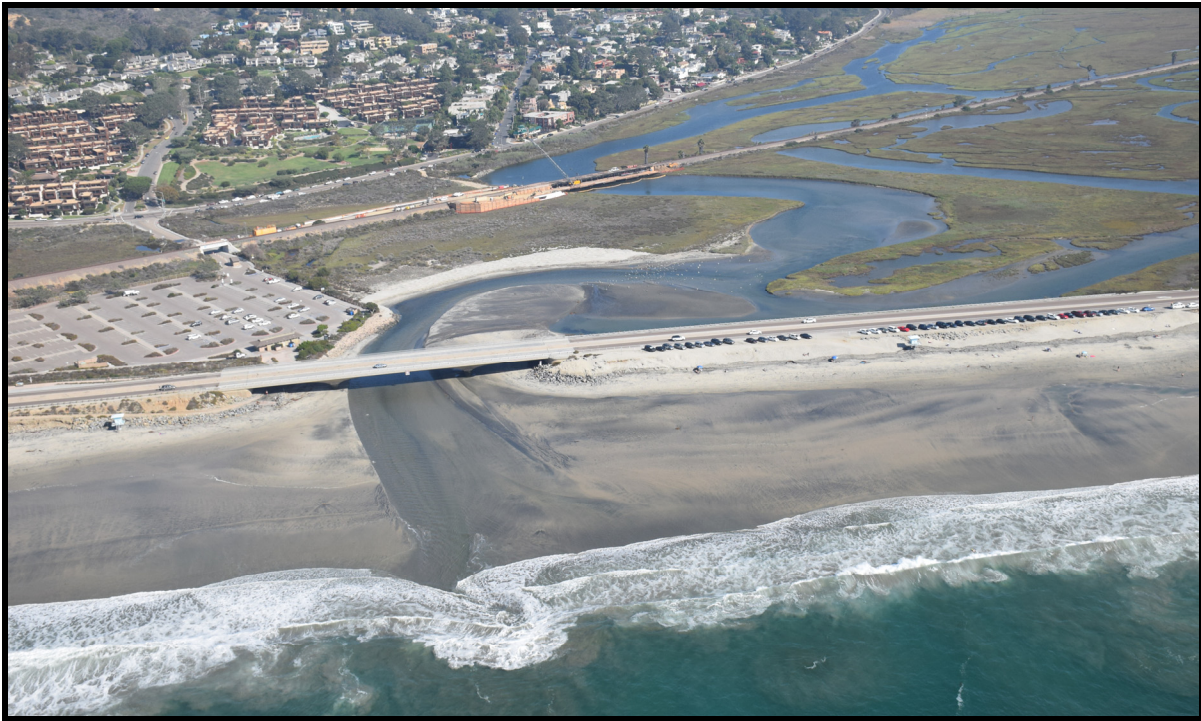
Plate 5. Los Peñasquitos Lagoon Entrance, October 2015

The Los Peñasquitos entrance channel is shown in Plate 5. Prior to the RBSP I, the unstabilized entrance to Los Peñasquitos Lagoon typically closed several times per year. Efforts to re-establish the entrance channel with earth-moving equipment date back to the 1960's. Based on data compiled by the Los Peñasquitos Lagoon Foundation (West, 2003), the lagoon was open to tidal access about 50% of the time between 1965 and 1984. More recently, the Los Peñasquitos Lagoon Foundation has funded a sustained effort to maintain tidal flow by mechanically opening or widening the channel several times each year (KEA
