**2020 REGIONAL BEACH  
MONITORING PROGRAM**

**ANNUAL REPORT**

**Coastal Frontiers Corporation**

April 2021

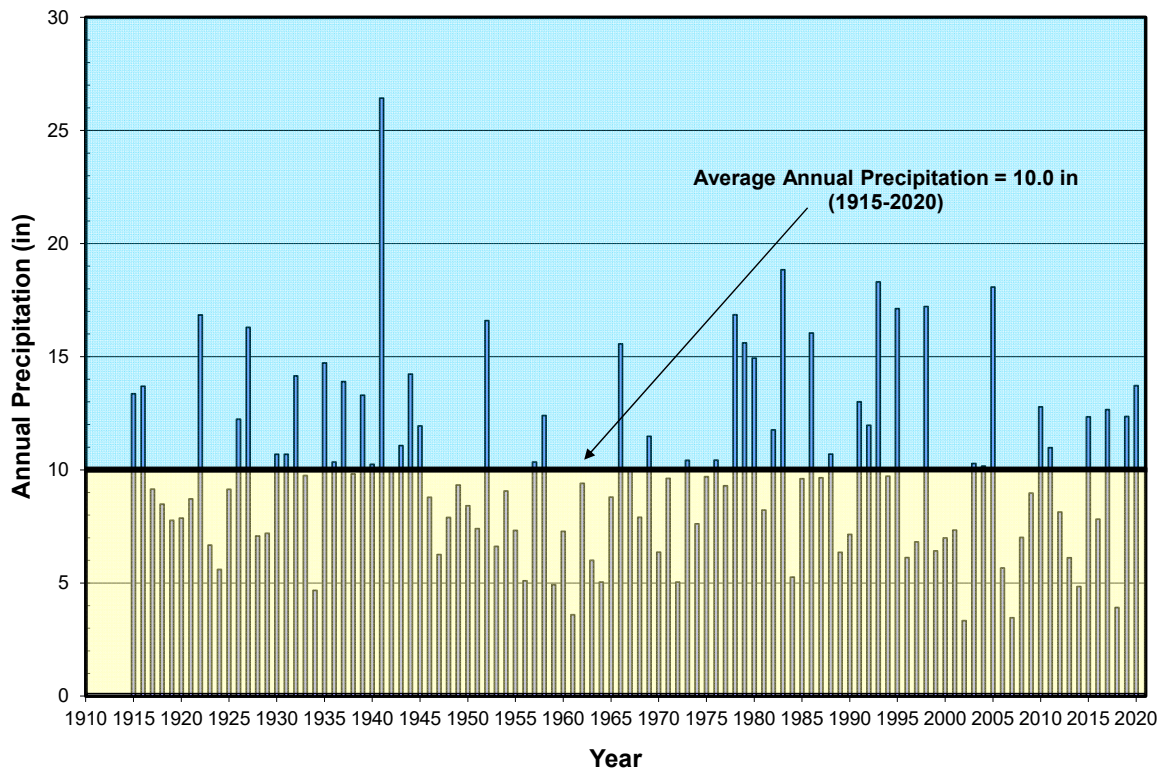
**Figure 3. Annual Precipitation at Lindbergh Field, 1915-2020**

Figure 3 shows the annual precipitation measured at Lindbergh Field from 1915 through 2020 (Western Regional Climate Center, 2020). The average value during the period of record was 10.0 inches, with a maximum of 26.4 inches in 1941 and a minimum of 3.4 inches in 2002. Above-average precipitation (13.7 inches) prevailed during the 2020 Monitoring Year.

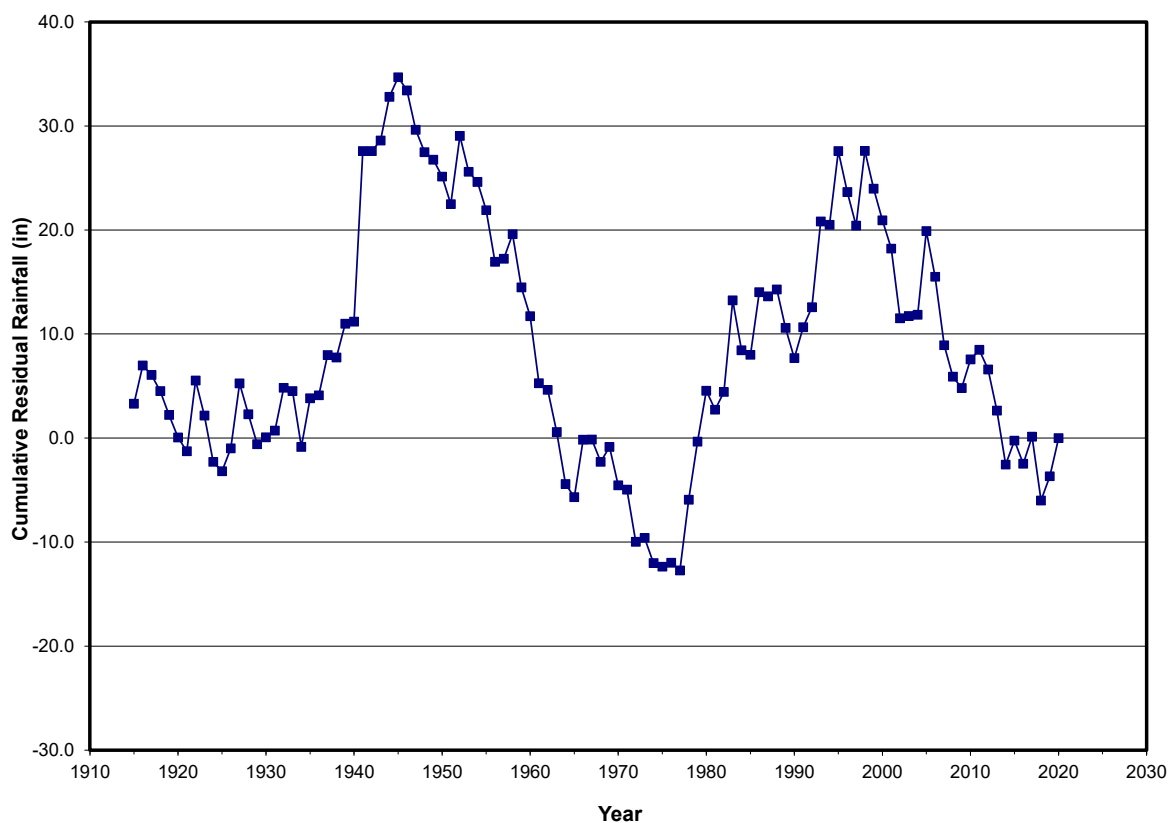
**Figure 4. Cumulative Residual Rainfall at Lindbergh Field, 1915-2020**

The cumulative residual rainfall at Lindbergh Field is shown in Figure 4. Residual rainfall represents the difference between the rainfall observed in a particular year and the average annual rainfall. When the residual values are summed over extended periods of time, the resulting cumulative values provide an indication of long-term climatic trends (Inman and Jenkins, 1999). A positive slope to the graph denotes a “wet” period of above-average precipitation, while a negative slope denotes a “dry” period of below-average precipitation.

Notwithstanding several short-term exceptions, the period from 1945 through 1977 can be characterized as dry, while the period from 1978 through the mid-1990’s can be characterized as wet. Predominately dry conditions have persisted since the 1997-98 El Niño event, with below-average rainfall recorded during 13 of the past 22 years. Above-average precipitation during four of the last six years (2015, 2017, 2019, and 2020) may signal a reversal of the recent trend.

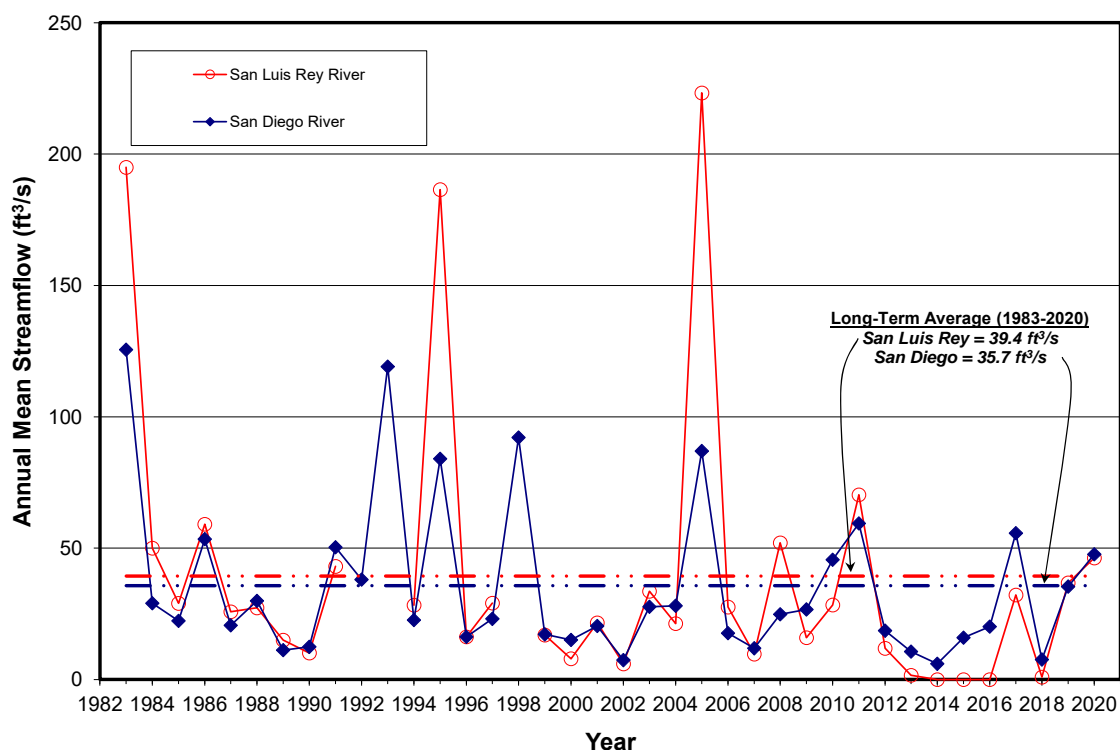
Figure 5. Annual Mean Streamflow in the San Luis Rey and San Diego Rivers, 1983-2020

Figure 5 presents the annual mean streamflow measured in each river between 1983 and 2020. Similar to the precipitation trends (Section 2.1), the flow in both rivers was below the long-term average for most of the past two decades. The flow exceeded the long-term average in one or both rivers during only five of the past 20 years. In keeping with the above normal precipitation observed during the 2020 Monitoring Year, the streamflow in both rivers also exceeded the historical average values. It should be noted that two substantial gaps exist in the data for the San Luis Rey River: (1) October 1992-August 1993, and (2) November 1997-May 1998. Both of these periods were characterized by high streamflow rates in the San Diego River, suggesting that the true long-term average for the San Luis Rey is higher than that shown in Figure 5.

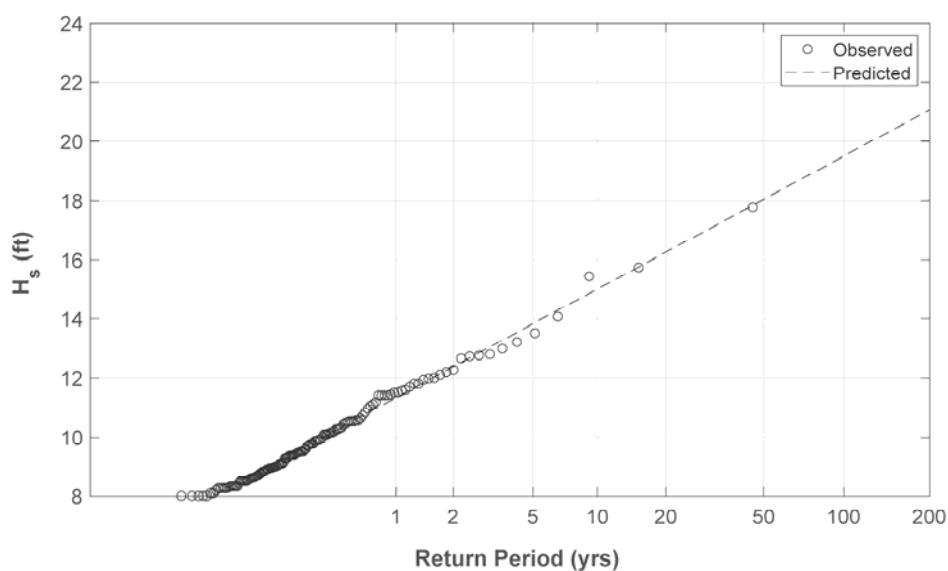
**Figure 6. Extreme Wave Events at CDIP Oceanside Buoy (1998-2020)**

Figure 6 shows the probability distribution function for extreme wave heights at the Oceanside Buoy. The extreme value statistics were derived according to the methodology outlined by Goda (2000), using a sample population of all storm events occurring during the 23-year period of record (1998 to 2020 Monitoring Years) with a significant wave height ( $H_s$ ) greater than or equal to 8.0 ft. This threshold ensured that at least one event was selected during each Monitoring Year. A Frechét distribution, fit using the method of least squares, was selected based the highest correlation ( $r^2 = 0.993$ ) among the three distribution functions investigated (Frechét, Gumbel, Weibull). The predicted 100-year wave height is 19.5 ft, while the largest event recorded at the site (17.8 ft in February 2016) corresponds to an estimated return period of 44 years.

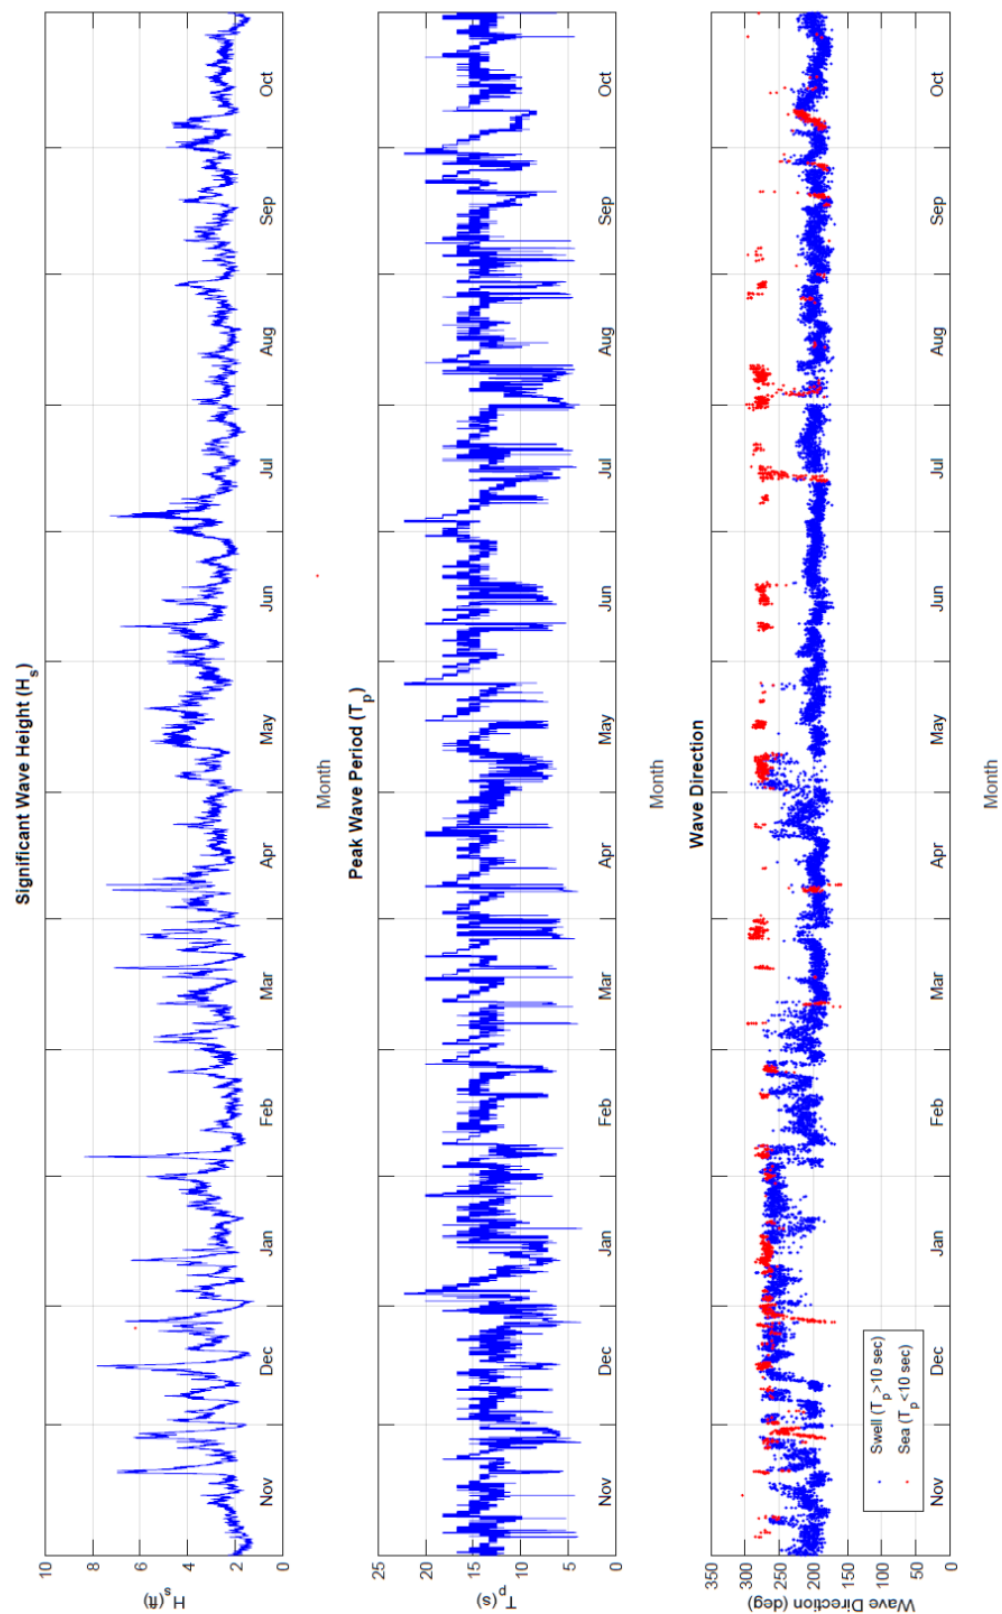
Figure 7. Wave Characteristics at the CDIP Oceanside Buoy, 2020 Monitoring Year

The significant wave height ( $H_s$ ), peak wave period ( $T_p$ ), and wave direction recorded half-hourly at the Oceanside Buoy during the 2020 Monitoring Year are presented as a time series in Figure 7. The only sustained period of northerly swell occurred from mid-December through January. Southerly swell typical of summer months prevailed from mid-March through October. The remainder of the monitoring year (February and November) was a transition period with a mixture of northerly and southerly swell. The greatest significant wave height recorded during 2020 occurred in February and measured just 8.3 ft (a return period of less than 1 year).

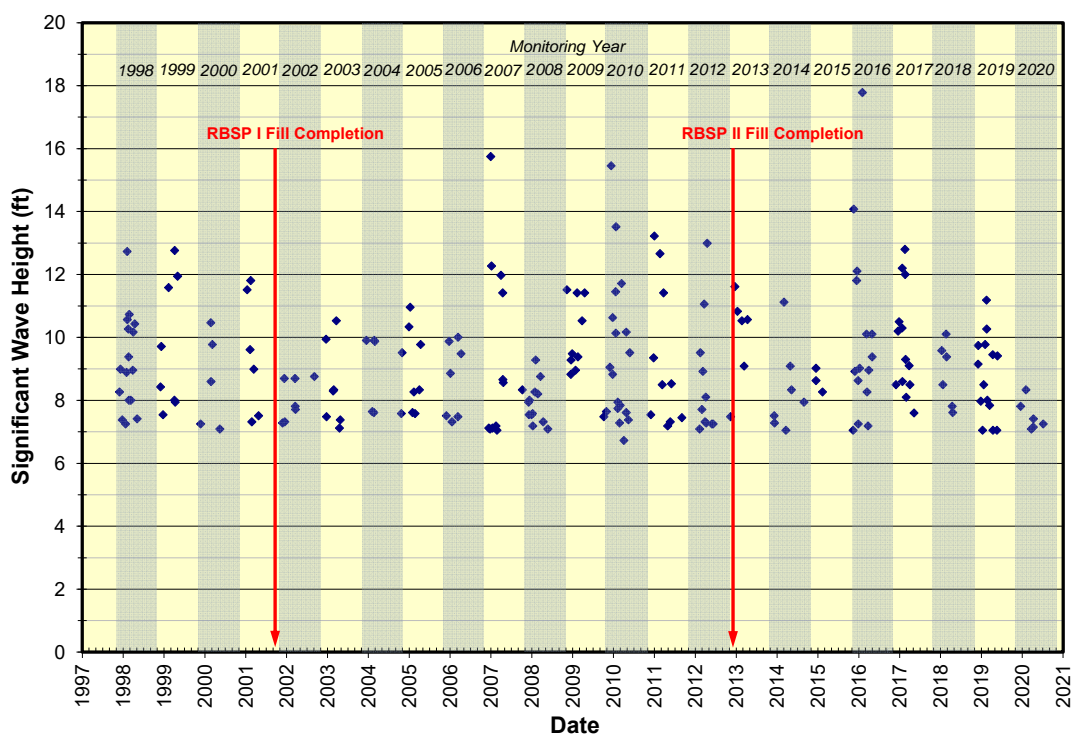
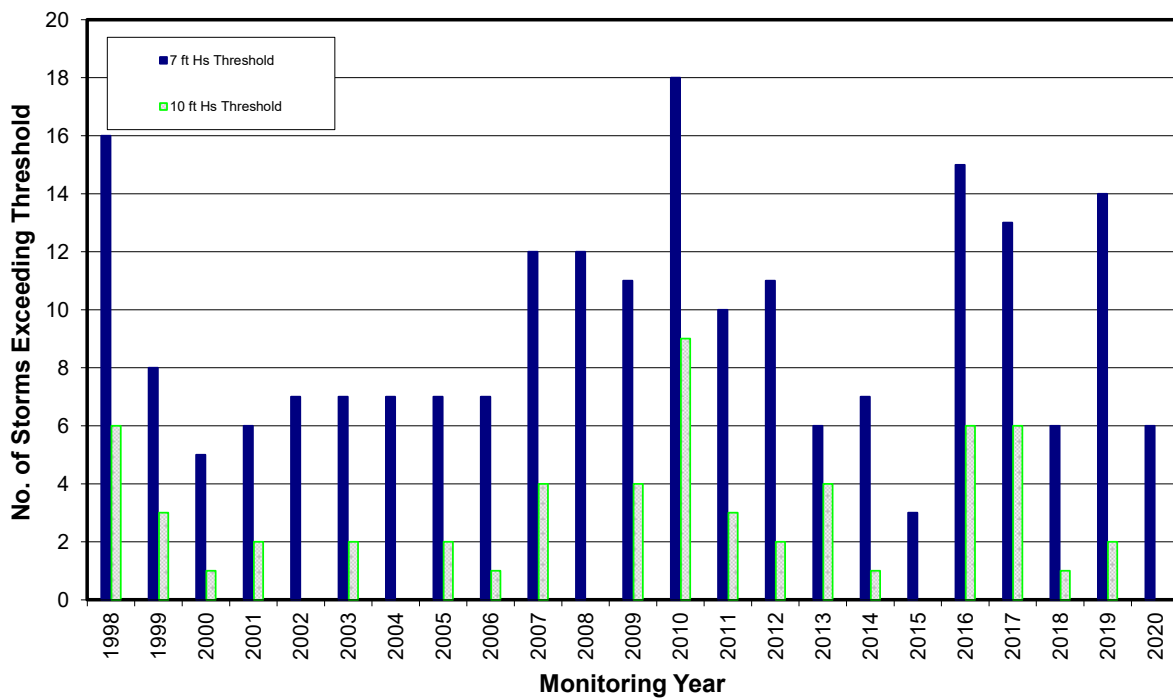
As indicated in Figures 8 and 9, sixteen storms with  $H_s$  surpassing 7 ft occurred during the 1997-1998 El Niño. Milder conditions prevailed from 1999 through 2006 (including the first six years following implementation of the RBSP I nourishment - 2001 to 2006), with  $H_s$  surpassing 7 ft between five and eight times per year, and surpassing 10 ft between zero and three times per year. Conditions were more severe during the next six years leading up to RBSP II (2007 to 2012), when  $H_s$  surpassed 7 ft between ten and eighteen times per year, and surpassed 10 ft between zero and nine times per year. The storm frequency in 2010 (a “strong” El Niño Year) was the highest during the period of record, surpassing that achieved during the 1997-1998 El Niño event. However, the storm persistence (Figure 10) was greater in 1998, with a higher number of days with  $H_s$  exceeding the threshold values. The storm frequency and persistence during the 2020 Monitoring Year were among the lowest on record.

Figure 8. Storm Events with Significant Wave Heights Exceeding 7 ft, 1998-2020

Figure 9. Storm Events per Year with Significant Wave Heights Exceeding 7 ft and 10 ft, 1998-2020

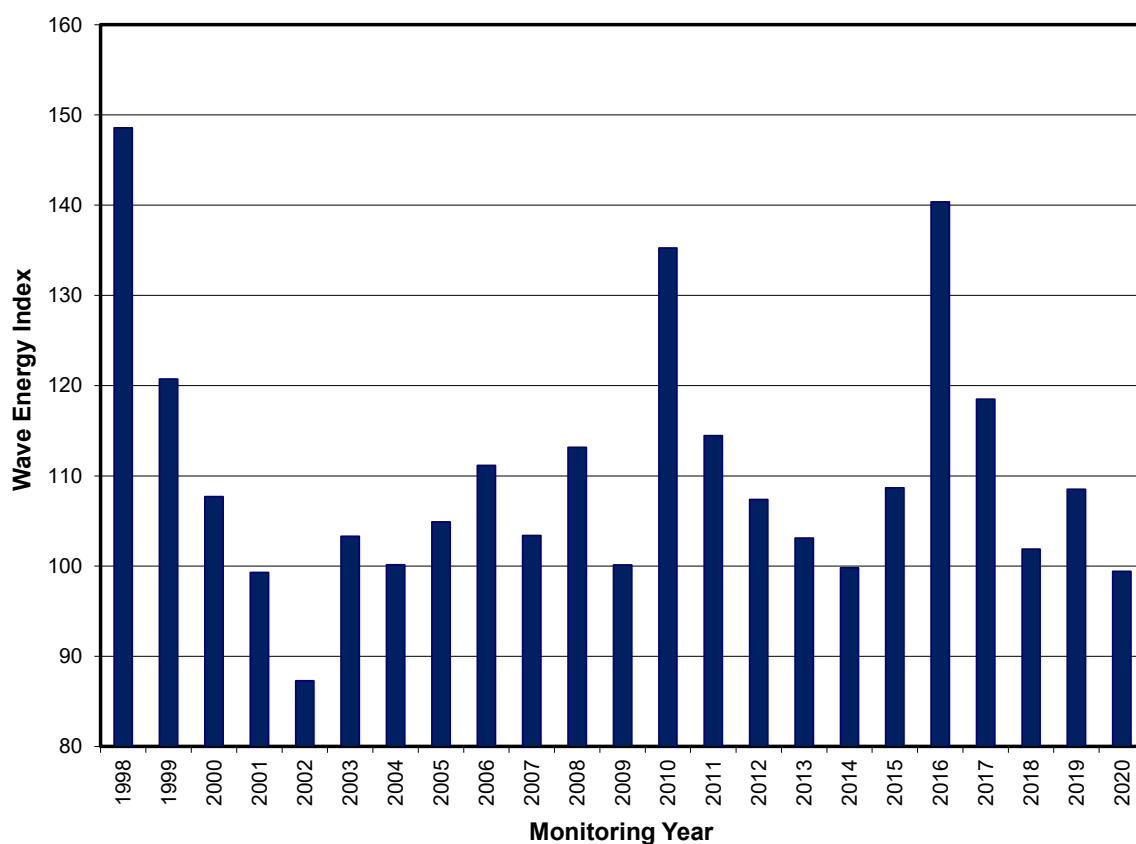
**Figure 11. Relative Incident Energy Index at the CDIP Oceanside Buoy, 1998-2020**

The computed values of  $E_r$  are shown in Figure 11. The highest Energy Index values correspond to the 1998, 2010 and 2016 El Niño years. The wave conditions in 1998 yielded the highest Energy Index value (149), followed by 2016 (140). Conditions were comparatively mild during the rest of the period of record. During the first eight years following the RBSP I (2002 to 2009) and the first three years following the RBSP II (2013 to 2015), the Energy Index values fell below 120. In keeping with the low storm frequency and persistence observed in 2020, the Energy Index in 2020 (99) also fell below average (tied for 2<sup>nd</sup> lowest on record).

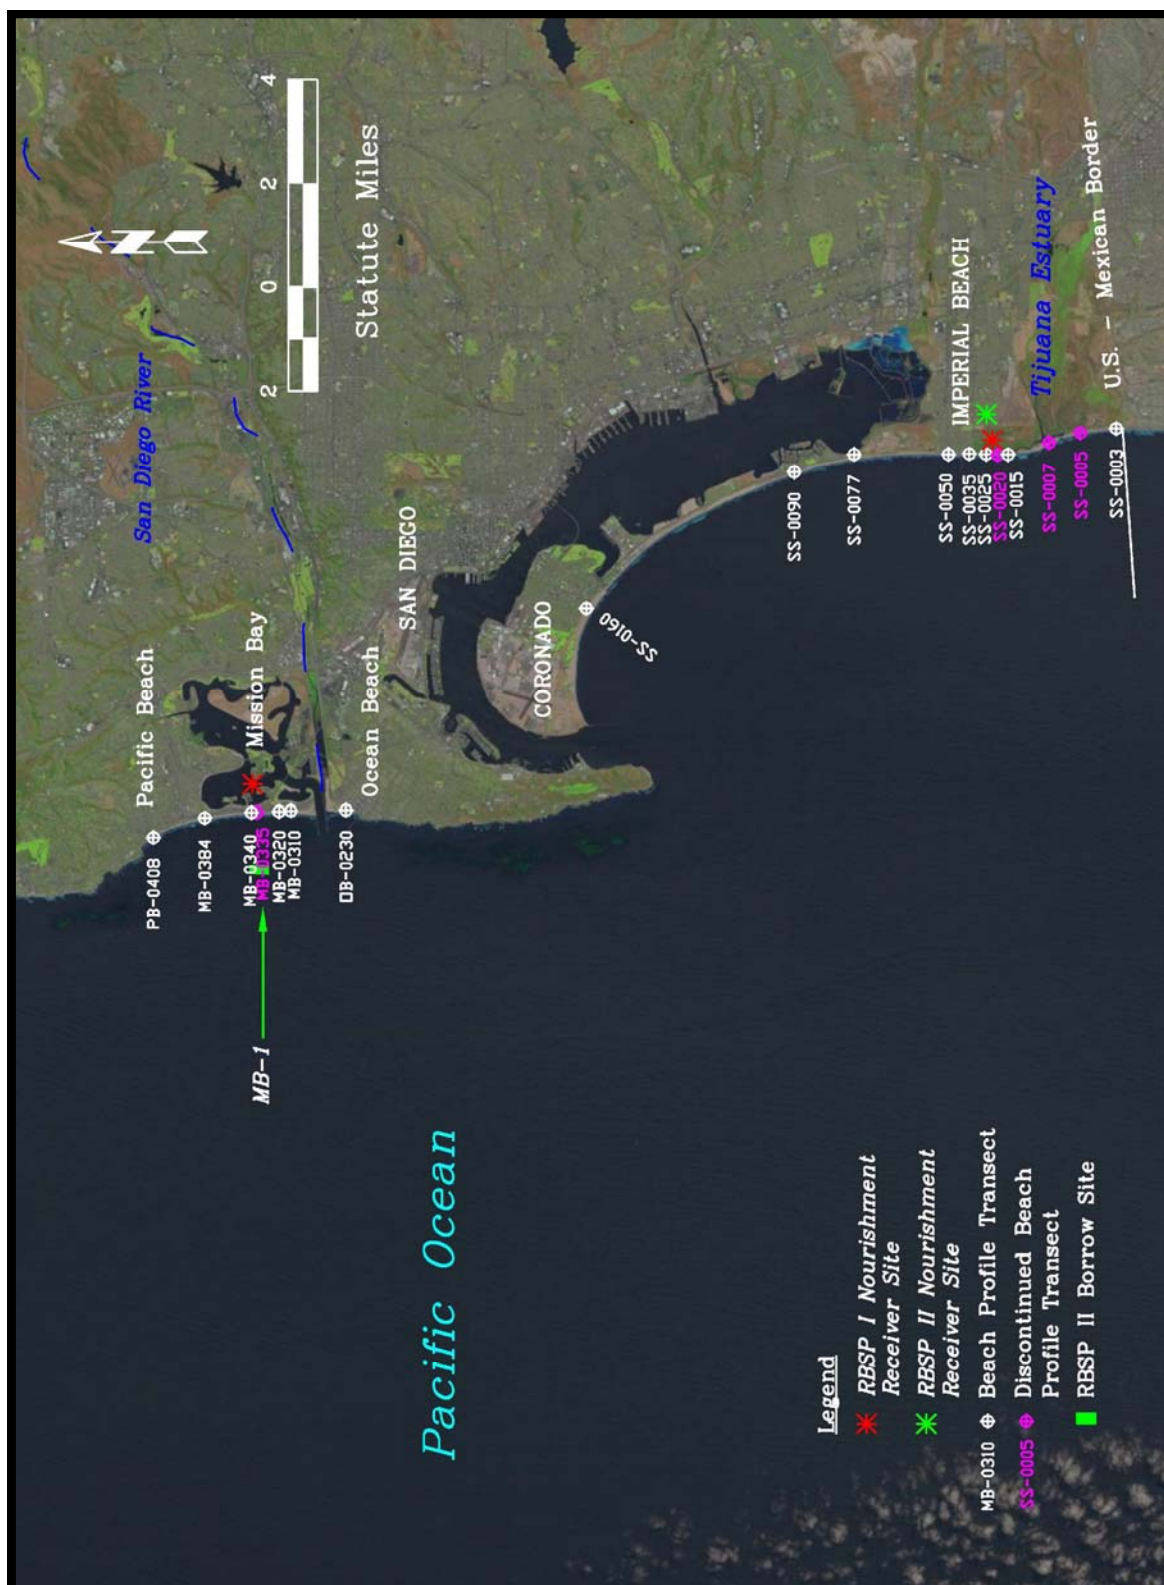
Figure 12a. Beach Profile Transects in the Silver Strand and Mission Beach Littoral Cells

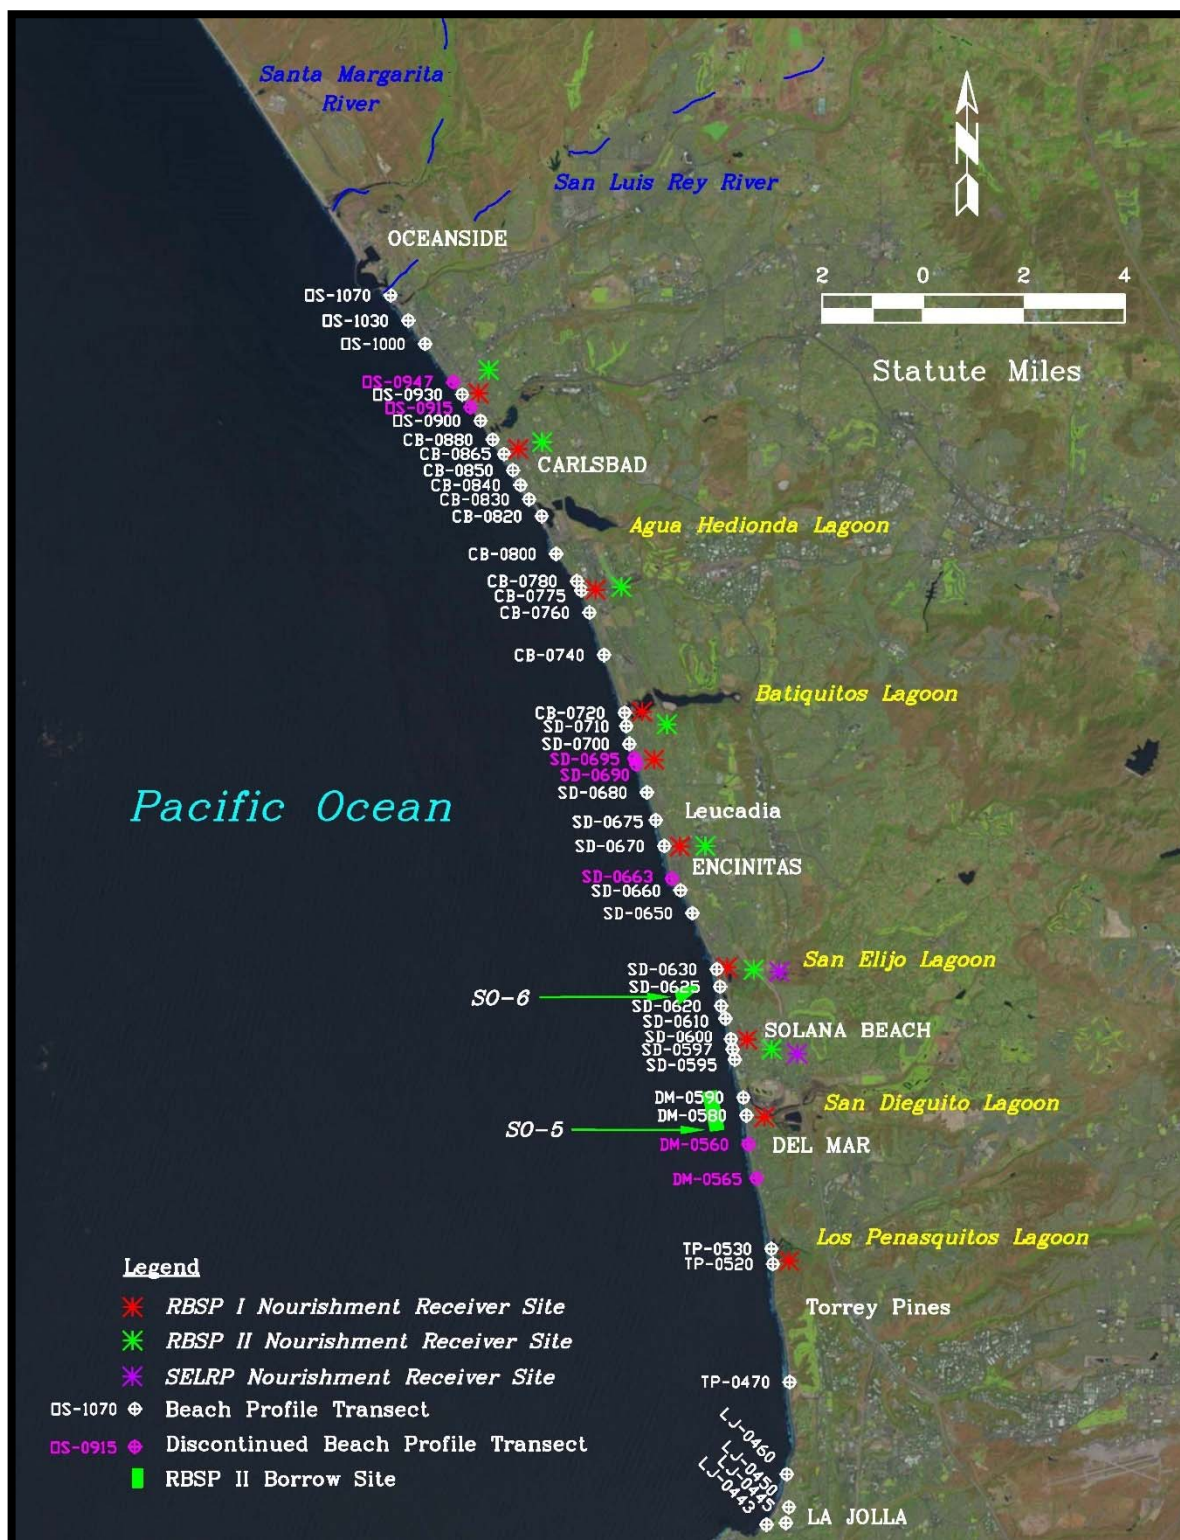
Figure 12b. Beach Profile Transects and Lagoon Entrances in the Oceanside Littoral Cell

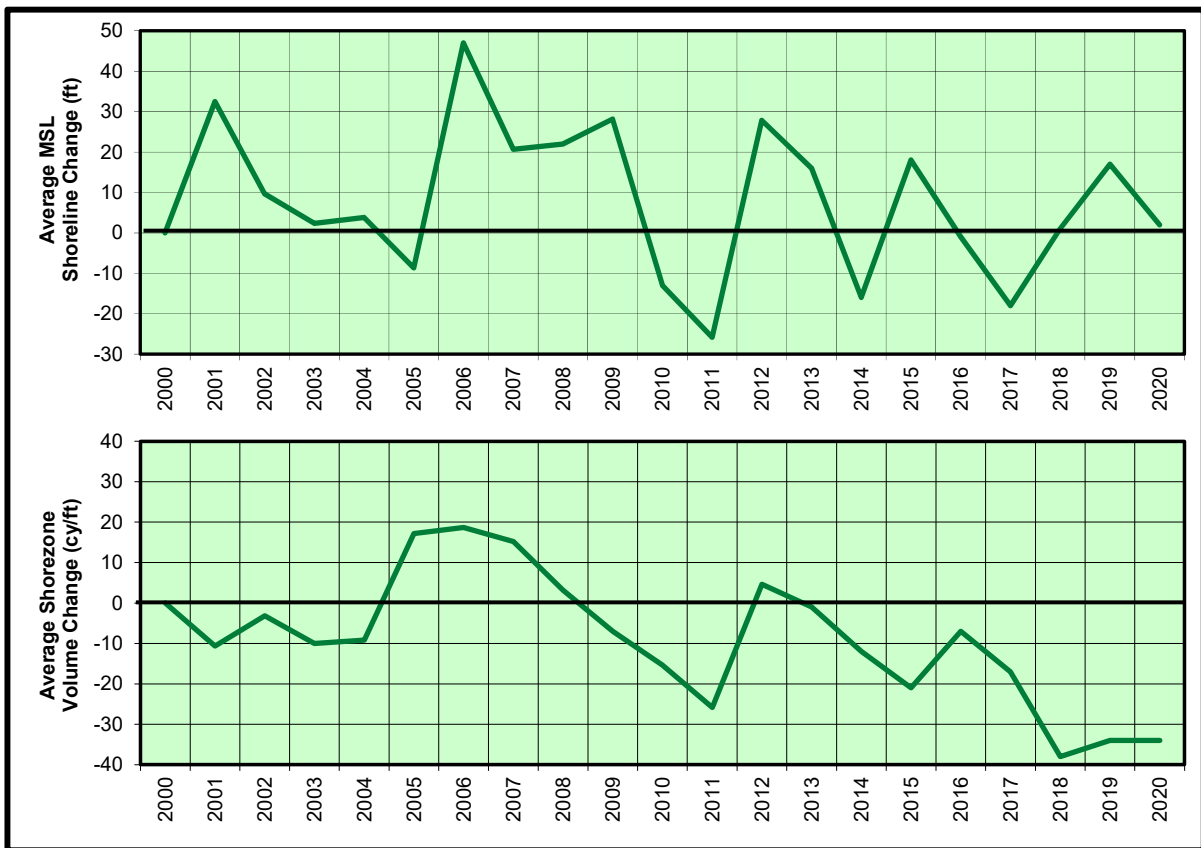
**Figure 16. Time Series of Average MSL Shoreline and Shorezone Volume Change Relative to Pre-RBSP I Condition in the Silver Strand Littoral Cell**

Figure 16 presents the average change in shoreline position and shorezone volume in the Silver Strand Cell at the time of each Fall survey relative to the pre-RBSP I condition (Fall 2000). The initial shoreline advance resulting from RBSP I was short-lived, and by 2005 the shoreline had retreated to pre-RBSP I levels. This response may be explained by the relatively small nourishment quantity and the use of only one receiver site in the cell.

above the pre-RBSP I value. The nourishment quantity during RBSP II was nearly four times higher than that provided under RBSP I. A trend of shoreline retreat then persisted over the next five years with a brief reversal in 2015. By 2017, the average shoreline position was 18 ft below the pre-RBSP I level. Shoreline advance occurred in 2018 and 2019, increasing the average shoreline position to 17 ft above the pre-RBSP I condition by the end of the 2019 Monitoring Year. Shoreline retreat in 2020 reduced beach widths to near the pre-RBSP I value. As indicated in Figure 14, the greatest shoreline advance during this period (40 ft) occurred in Imperial Beach. Shoreline retreat in excess of 10 ft prevailed only at Coronado (a loss of 44 ft).

The shorezone volume decreased following the RBSP I and remained below the pre-RBSP I value until opportunistic nourishment activities were conducted in 2005 (301,000 cy placed in the nearshore off Imperial Beach, Section 3.1). The initial losses in this cell may reflect the fact that the two transects located within the Imperial Beach fill do not pre-date the RBSP I, and thus the likely volume gains at these transects were not included in the calculations. Following the gains produced by the opportunistic nourishment in 2005, the

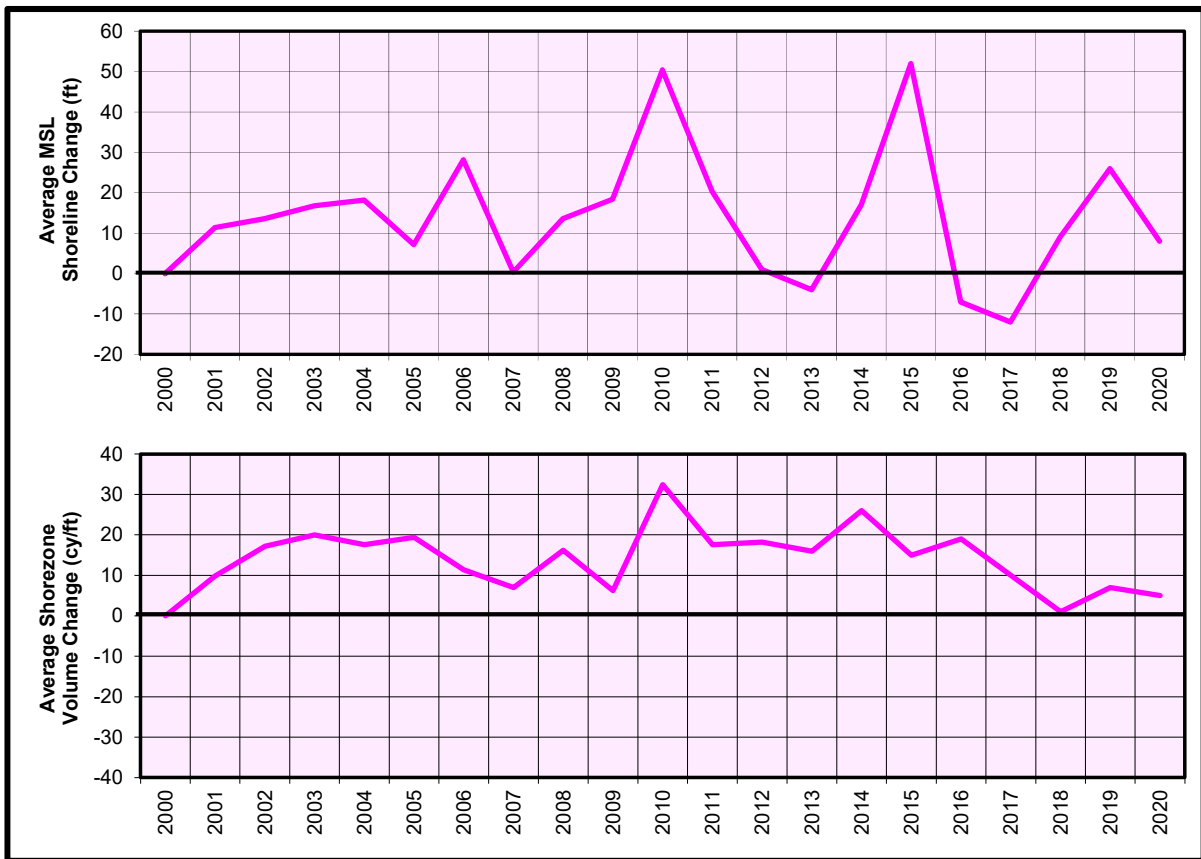
**Figure 17. Time Series of Average MSL Shoreline and Shorezone Volume Change Relative to Pre-RBSP I Condition in the Mission Beach Littoral Cell**

The RBSP I beach nourishment in the Mission Beach Cell was limited to a relatively small sand placement at one receiver site. The shoreline gains attributable to the RBSP I persisted through 2005 (Figure 17). Unanticipated shoreline advance then occurred in 2006, but significant shoreline retreat in 2007 returned the average beach width in the cell to the pre-RBSP I condition. Shoreline advance in 2008 and 2009 restored the beach widths to above the pre-RBSP I levels.

In 2010, the placement of 450,000 cy of sand during opportunistic beach nourishment activities produced significant shoreline gains. The resulting average shoreline position exceeded the pre-RBSP I value by nearly 50 ft. As the above-water nourishment material dispersed, three consecutive years of shoreline retreat (2011 through 2013) reduced beach widths to below pre-RBSP I levels. This trend then was reversed, with shoreline advance in both 2014 and 2015 increasing the average beach width in the cell to the highest levels observed during the period of record.

The El Niño conditions that prevailed in 2016 produced substantial shoreline retreat. Additional losses during 2017 reduced the average beach width to the lowest value recorded during the 20-year Post-RBSP I Period. Shoreline advance in 2018 and 2019 was followed by losses in 2020. The average beach width at the time of the Fall 2020 survey exceeded the pre-RBSP I condition by 8 ft. As suggested in Figure 14, the gains were concentrated in Mission Beach.

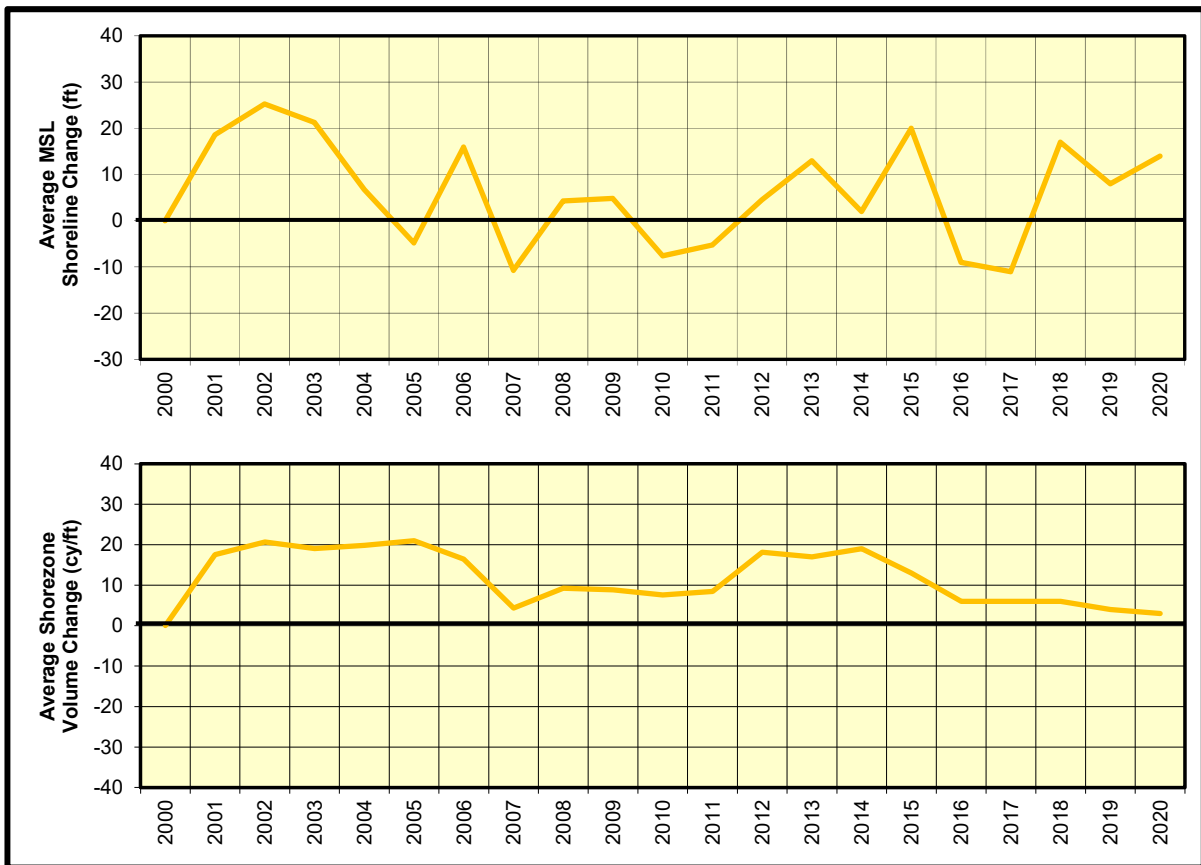
**Figure 20. Time Series of Average MSL Shoreline and Shorezone Volume Change Relative to Pre-RBSP I Condition in the Oceanside Littoral Cell**

Time series of the average shoreline and shorezone volume change at the time of each Fall survey relative to the pre-RBSP I condition (Fall 2000) are presented in Figure 20. The RBSP I produced substantial shoreline advance in 2001. Additional gains occurred in 2002 as the fill material dispersed alongshore to adjacent beaches. A trend of shoreline loss then prevailed, with reversals in 2006, 2008, and 2011. At the end of the 2011 Monitoring Year, the average shoreline position was below the pre-RBSP I level.

Shoreline advance prevailed during 2018 as a result of the SELRP nourishment material placed in Cardiff and Solana Beach, and increased the average shoreline position above pre-RBSP I levels for the first time since 2015. Shoreline retreat in 2019 was followed by modest gains in 2020. As a result, the average MSL shoreline position remained above the pre-RBSP I value. As indicated in Figure 18, the greatest post-RBSP I gains (up to 168 ft) were concentrated in Cardiff and Solana Beach. Shoreline gains also prevailed in North Carlsbad and parts of Oceanside and La Jolla. Shoreline losses were most prevalent in the region from South Carlsbad through Encinitas, where the average shoreline retreat was 35 ft.

The sediment volume gains that occurred in the Oceanside Cell following the RBSP I persisted with minimal change through 2006 – outlasting the shoreline gains. The shorezone volume decreased in 2007 in response to energetic wave conditions, and then remained relatively constant through 2011. The RBSP II nourishment material provided in 2012 yielded additional gains. Similar to the shoreline changes, the magnitude of the volume increase was less than that produced after RBSP I due to the reduced nourishment quantities. However, building on a foundation of modest gains persisting from the RBSP I and several small opportunistic nourishment efforts, the net result was an average shorezone volume similar to that resulting from the RBSP I (2001). The shorezone volume then remained relatively stable in 2013 and 2014. Losses during the next two years reduced the shorezone volume to near the pre-RBSP I value, where it remained largely unchanged through 2020 despite of the placement of the SELRP beach nourishment material.

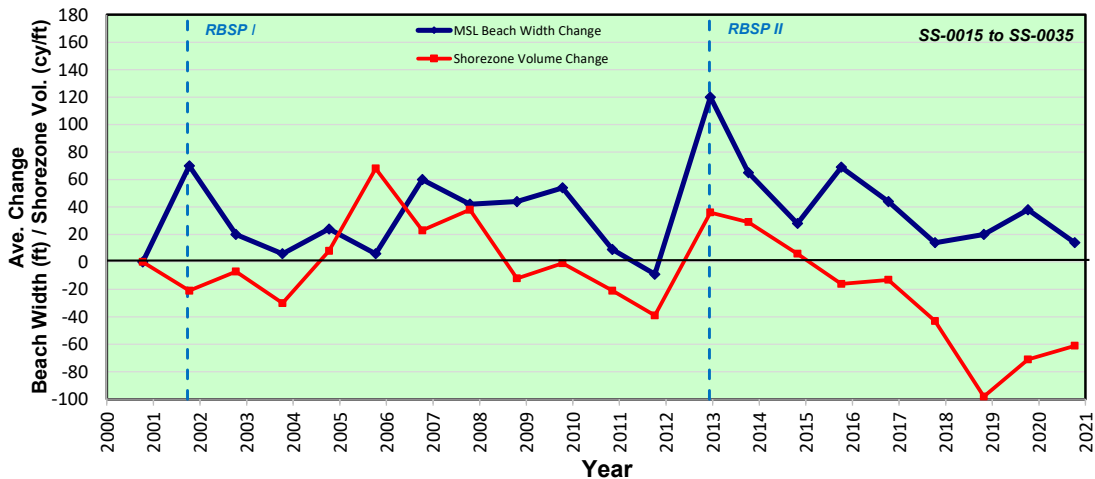
**Figure 21. Beach Width and Shorezone Volume Changes in the Imperial Beach Sub-Reach**

The initial benefits of the 120,000 cy of sand placed at Imperial Beach during RBSP I were short-lived, and by 2005 beach widths in the sub-reach were only slightly above the pre-RBSP I condition. However, the placement of 301,000 cy of opportunistic sand in 2005, and of 450,000 cy of material in 2012 as part of the RBSP II, helped maintain beach widths above the pre-RBSP I values for all but one year since 2005 (2011). The RBSP II brought considerably more gains than the RBSP I due to the larger nourishment volume placed during the second project. A trend of decreasing shoreline positions and shorezone volumes persisted after each of the nourishment projects, suggesting that the net sediment budget in Imperial Beach is negative and sand is gradually leaving the sub-reach. At the time of the Fall 2020 survey, beach widths continued to exceed the pre-RBSP I condition (average gain of 14 ft). In contrast, the shorezone volume fell well short of the pre-project benchmark (average loss of 61 cy/ft).

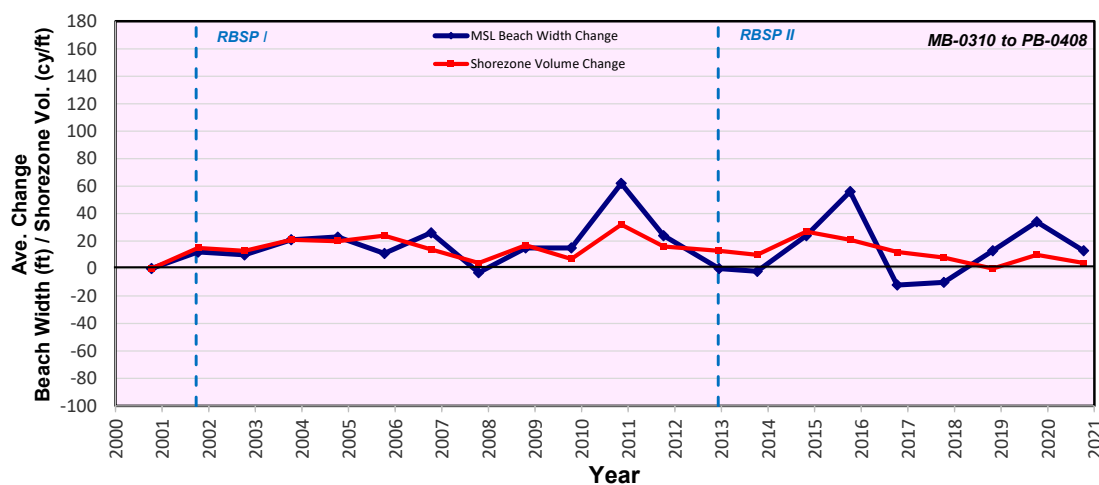
Figure 23. Beach Width and Shorezone Volume Changes in the Mission Beach Sub-Reach

In Mission Beach, the positive effects of the RBSP I (151,000 cy) were modest but sustained. Both the beach width and shorezone volume gains persisted through 2009. In 2010, the 450,000 cy Corps-sponsored beach nourishment further improved the beach condition. A gradual trend of shorezone volume loss then persisted, reducing the average shorezone volume to near pre-RBSP I levels by Fall 2020. While a general trend of beach width retreat also has prevailed since 2010, notable reversals occurred in 2015, 2016, 2018 and 2019. At the time of the Fall 2020 survey, the average shoreline position exceeded the pre-RBSP I value by 13 ft. As indicated in Section 3, Mission Beach was not included in RBSP II.

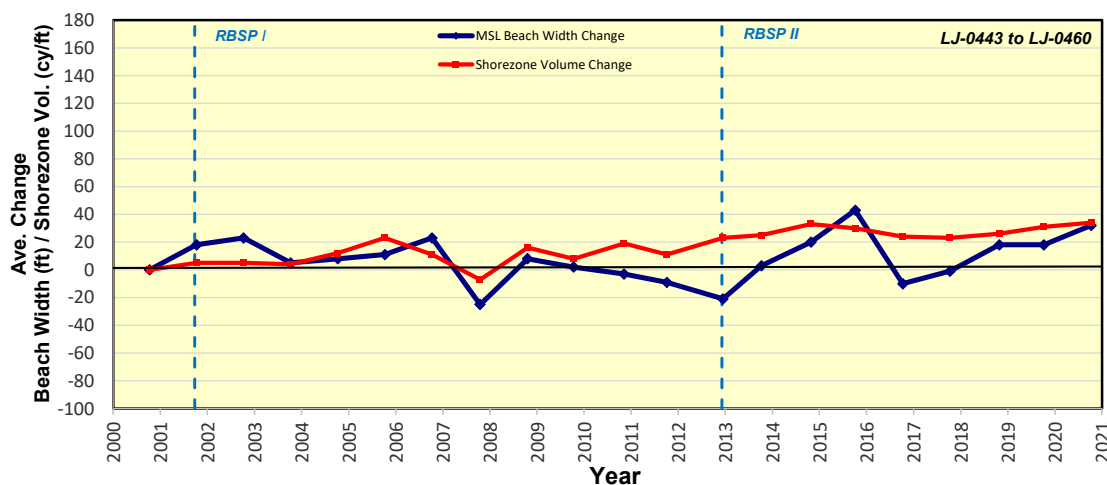
Figure 24. Beach Width and Shorezone Volume Changes in the La Jolla Sub-Reach

La Jolla did not receive direct nourishment as part of either RBSP I or RBSP II. In addition, opportunistic sand placement has not occurred in the area during the period of record. The trend of shorezone volume gains observed in the sub-reach since 2000 appear to be attributable to the gradual downcoast migration of nourishment material placed elsewhere in the Oceanside Cell. A general trend of increasing beach widths prevailed between 2000 and 2006, followed by decreasing beach widths through 2012. With the exception of the sharp retreat following the 2016 El Niño, beach widths have tended to increase since the RBSP II material was placed at upcoast beaches in 2012. The average shoreline position and shorezone volume at the time of the Fall 2020 survey exceeded the corresponding pre-RBSP I values (net gains of 32 ft and 34 cy/ft, respectively).

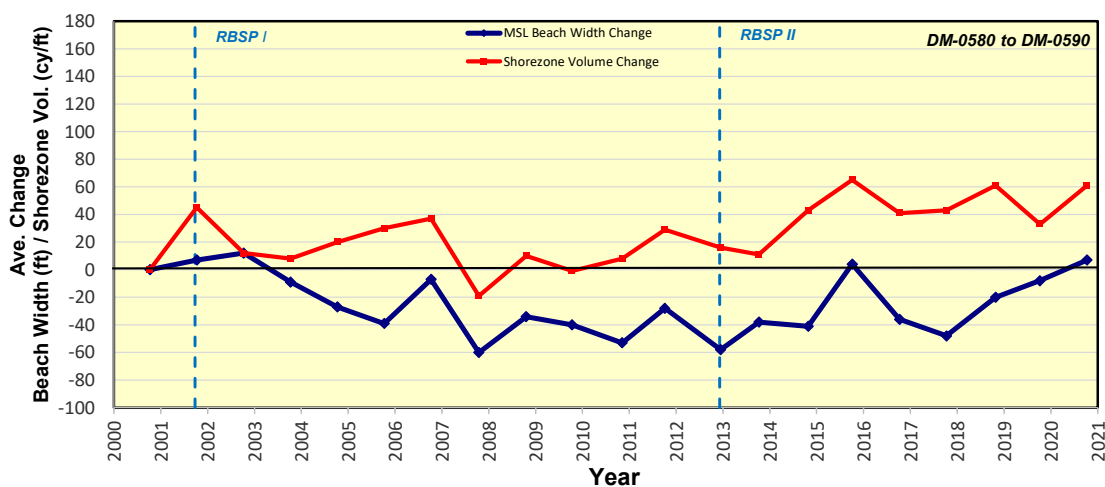
Figure 25. Beach Width and Shorezone Volume Changes in the Del Mar Sub-Reach

Del Mar received 183,000 cy of sediment during the RBSP I, and also benefited from the sand placements directly upcoast in neighboring Solana Beach and Cardiff as part of RBSP II and the SELRP. In addition the Del Mar beaches benefit from periodic bypassing at San Dieguito Lagoon (about 7,000 cy/yr). Although the initial shorezone volume gain following RBSP I was modest and additional material was not provided as part of RBSP II, the average sand volume in the sub-reach has exceeded the pre-RBSP I condition for most of the period (with years 2007 and 2009 being the exceptions). Both the shorezone volume and MSL shoreline have trended upward since 2013 even though Del Mar did not receive direct nourishment under RBSP II. This outcome suggests that, similar to La Jolla, Del Mar benefited from the gradual migration of nourishment material placed at upcoast sites (most recently the SELRP beach fills). At the time of the Fall 2020 survey, the average MSL shoreline position exceeded the pre-RBSP I condition for just the fourth time since 2000.

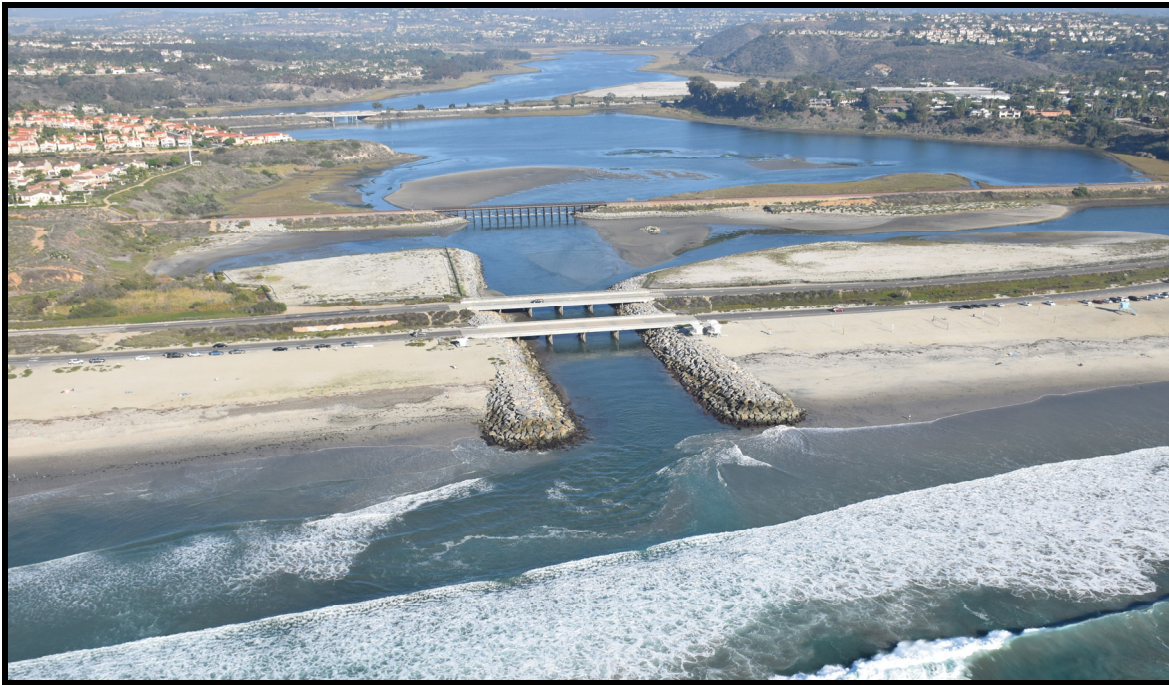
**Plate 2. Batiquitos Lagoon Entrance, October 2015**

Prior to 1994, the entrance to Batiquitos Lagoon was unstabilized and prone to frequent closure (SANDAG, 1999b). As part of the Batiquitos Lagoon Restoration Project conducted between 1994 and 1997, two rubble mound jetties were constructed at the entrance and 1.8 million cy of sediment were dredged from the wetlands. Plate 2 shows the condition of the Batiquitos Lagoon entrance channel in October 2015.

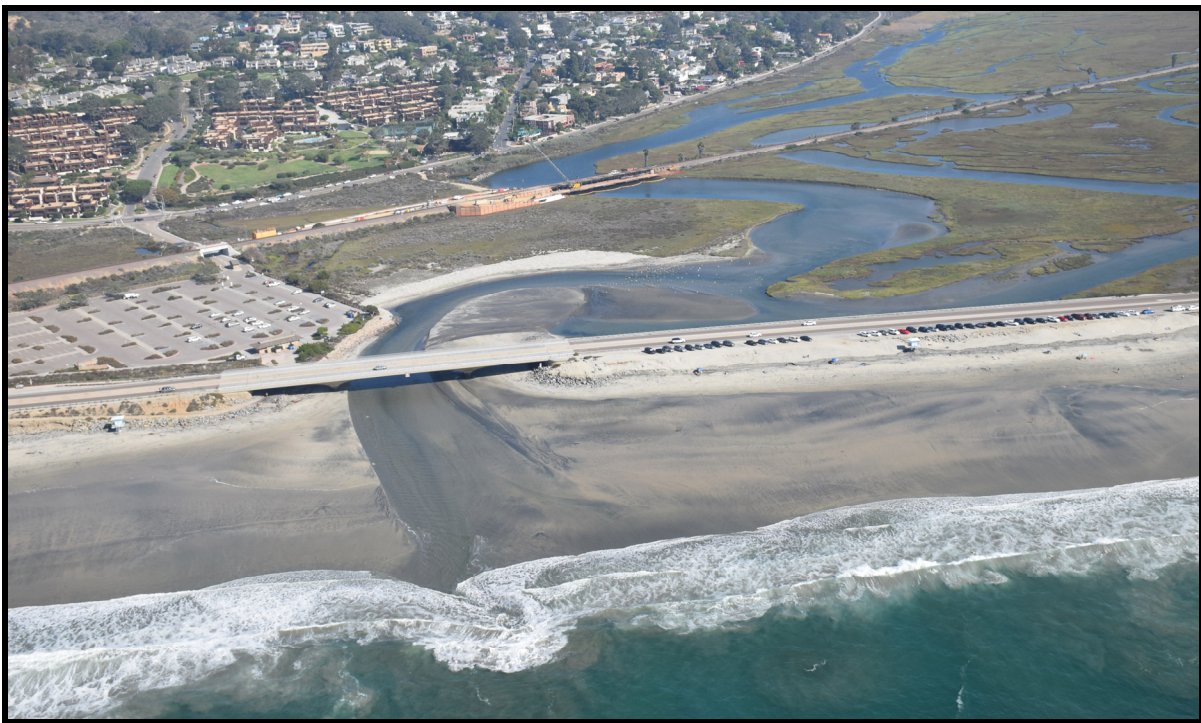
**Plate 5. Los Peñasquitos Lagoon Entrance, October 2015**

The Los Peñasquitos entrance channel is shown in Plate 5. Prior to the RBSP I, the unstabilized entrance to Los Peñasquitos Lagoon typically closed several times per year. Efforts to re-establish the entrance channel with earth-moving equipment date back to the 1960's. Based on data compiled by the Los Peñasquitos Lagoon Foundation (West, 2003), the lagoon was open to tidal access about 50% of the time between 1965 and 1984. More recently, the Los Peñasquitos Lagoon Foundation has funded a sustained effort to maintain tidal flow by mechanically opening or widening the channel several times each year (KEA Environmental, 2001). As a result, the lagoon was open to tidal exchange over 90% of the time between 1994 and 2001 (Williams, 1996, 1997; Williams *et al.*, 1995, 1998, 1999;
